Via Email: *sample@sample.com*  
Property: **Sample Condominiums**  
**123 Sample Rd, Sample, 12345**

Service: **FULL RESERVE STUDY**

Project No.: 202511-10

Site Inspection performed December 10, 2025  
*Submitted February 2, 2026*

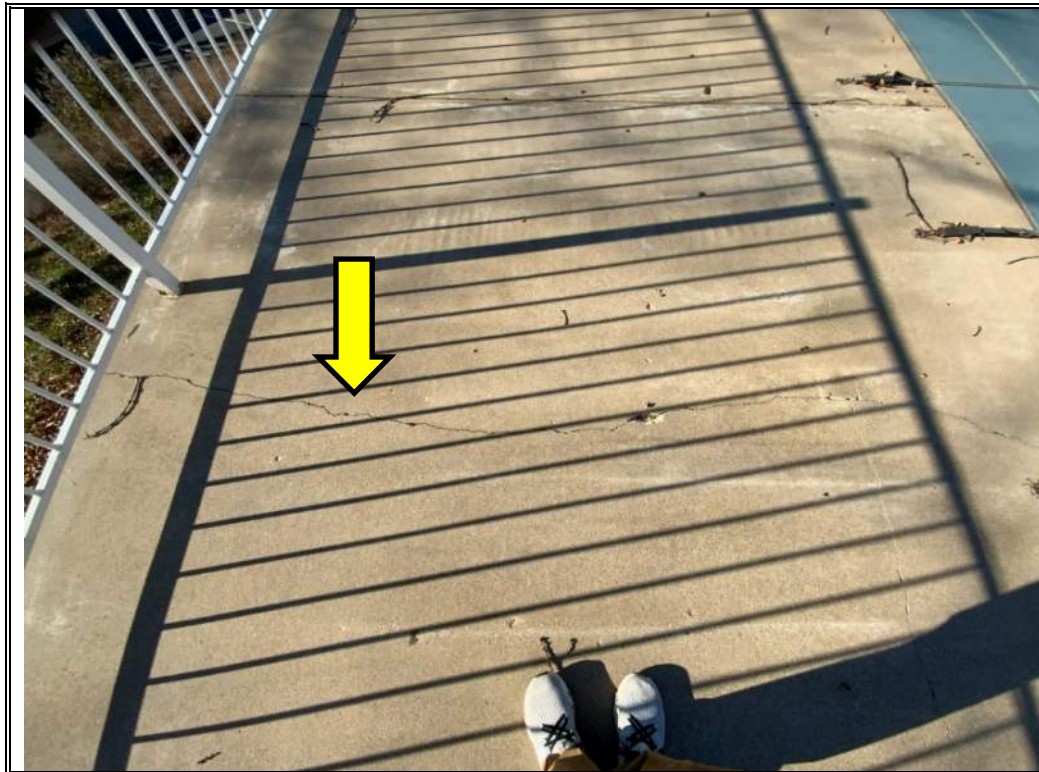
Cracking observed  
in the concrete  
pool deck

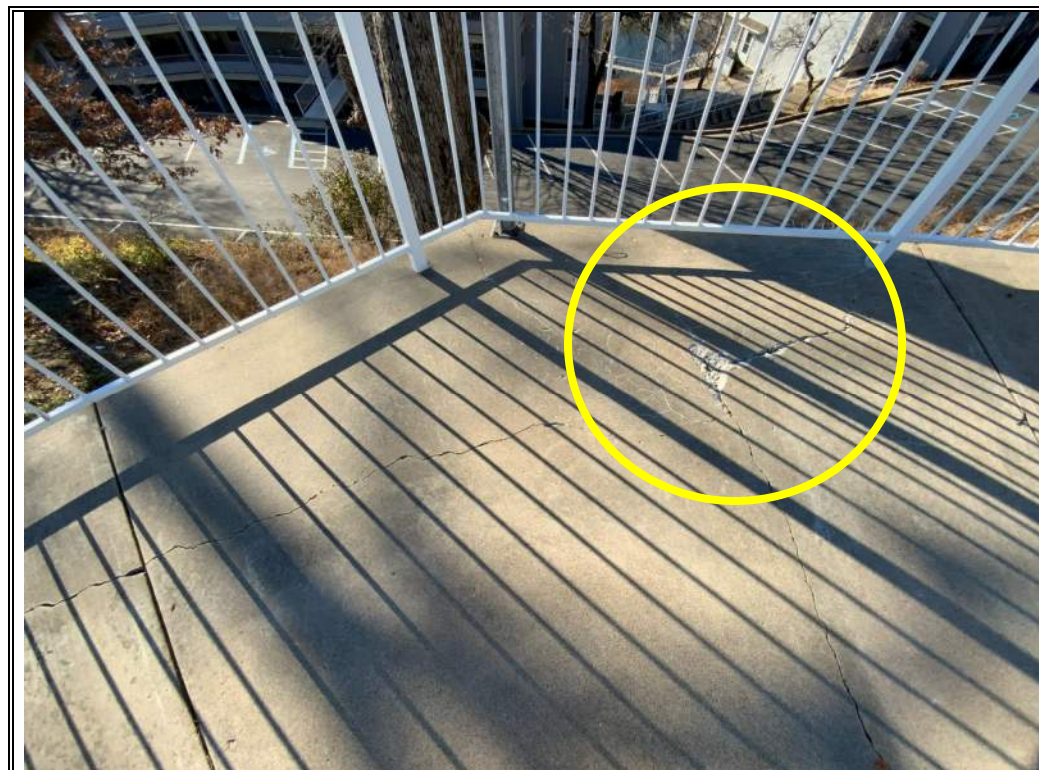
**Photo Number**  
**9**

Cracking observed  
in the concrete  
pool deck

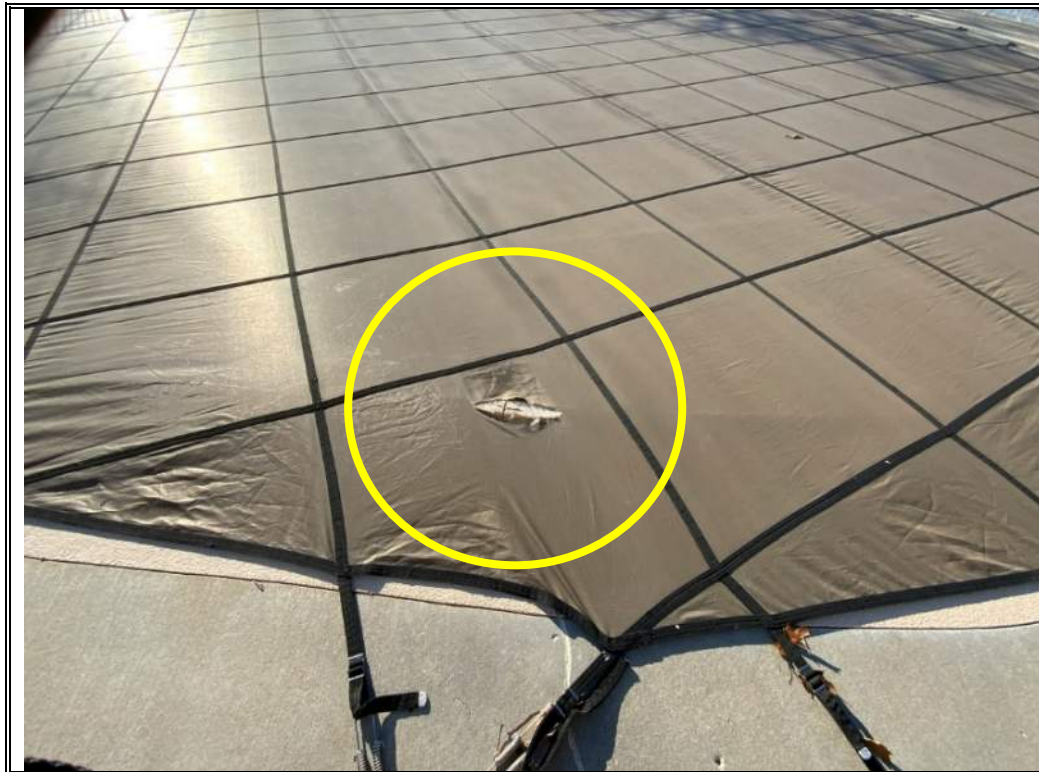
Observed tears in  
the lower pool  
cover

| ASSET N° | NAME | NEXT<br>ACTIVITY | EST<br>LIFE | ADJ<br>LIFE | REM<br>USEFUL<br>LIFE | UNIT<br>COST | QTY | YEAR 1<br>REPLACEMENT<br>COST |
|---|---|---|---|---|---|---|---|---|
| 5 | Replace lower pool cover | 01/01/2027 | 8y | 8y | 0y | \$4.82 | 2,400 SF | \$11,570 |

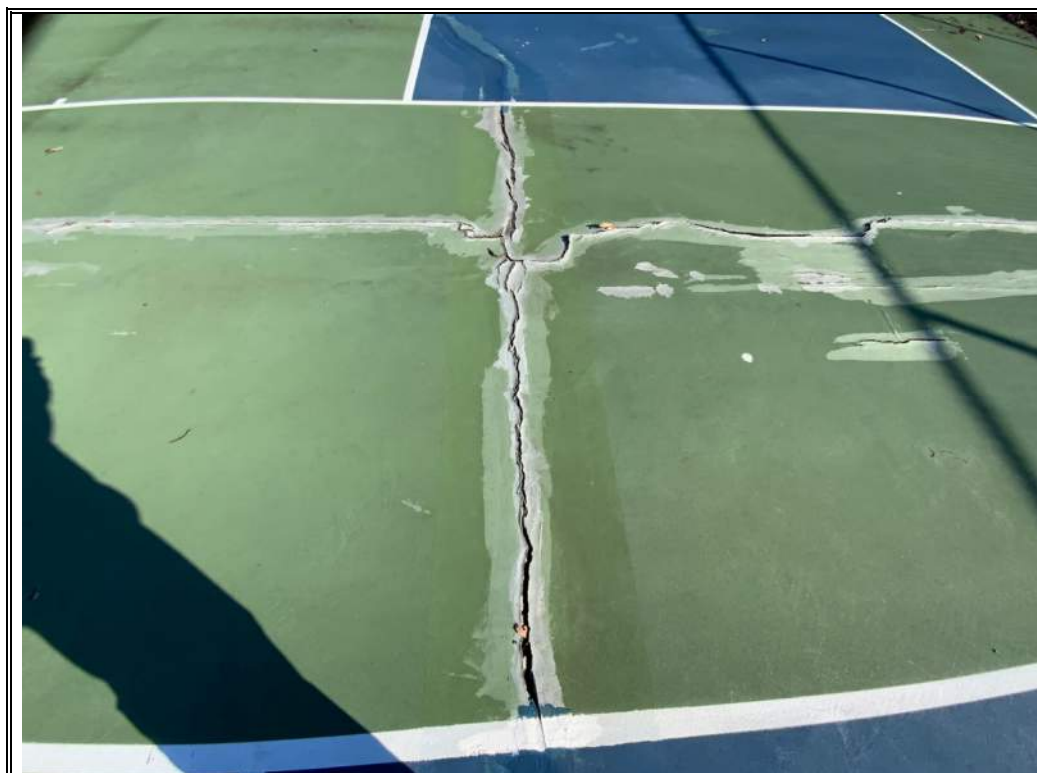
Severe cracking  
and deterioration  
in the upper tennis  
court surfaces

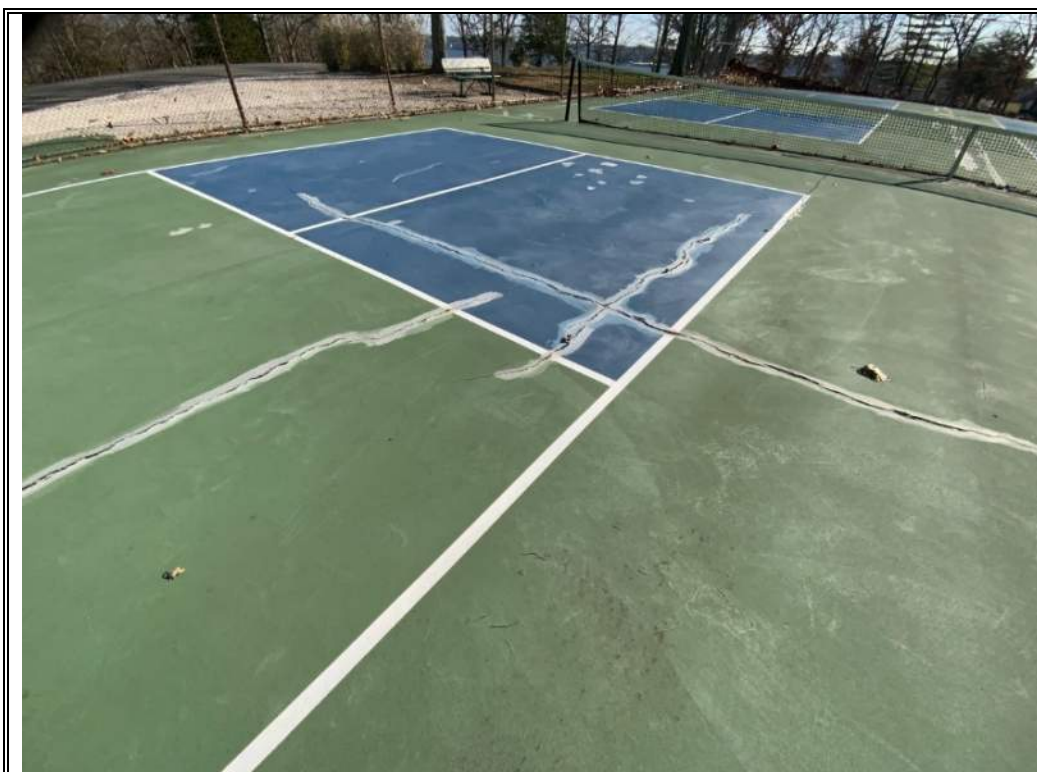
**Photo Number**  
**19**

Severe cracking  
and deterioration  
in the upper tennis  
court surfaces

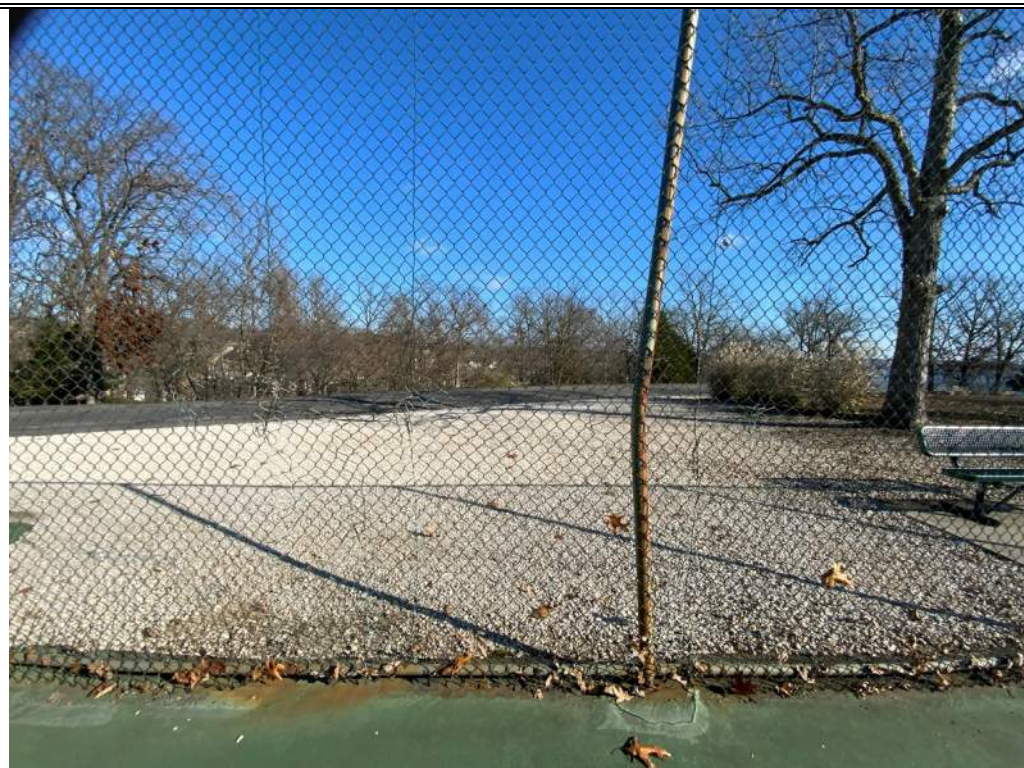
Damaged fencing  
at the upper tennis  
court

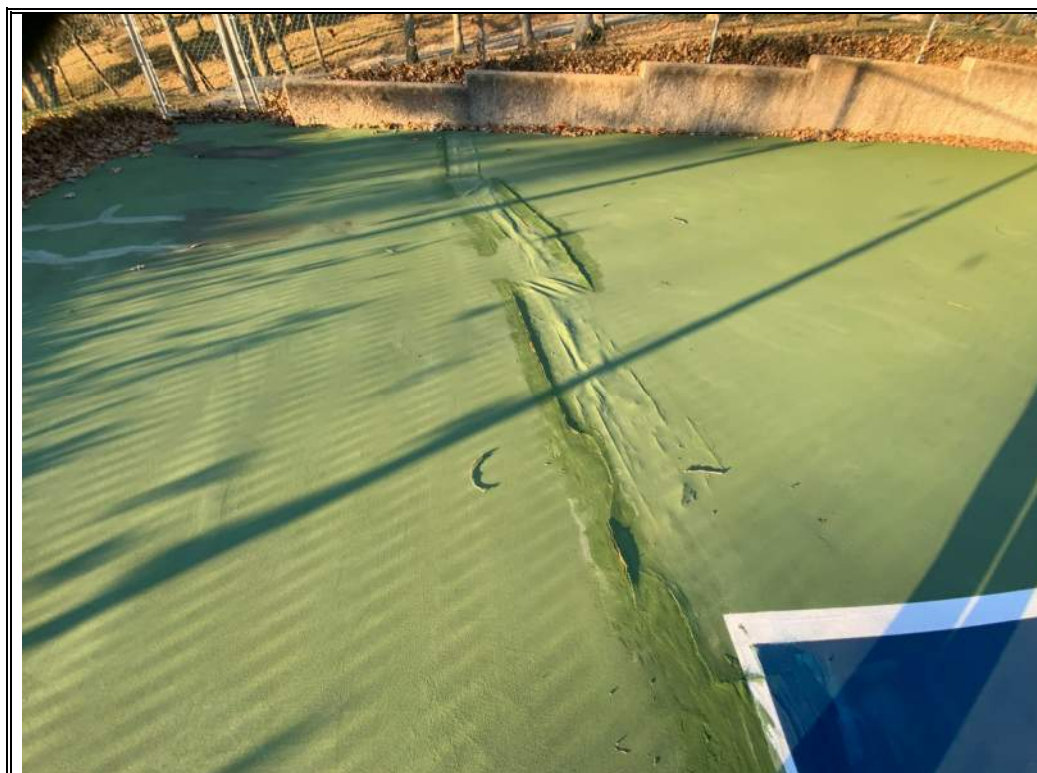
Surface  
deterioration in the  
lower tennis courts

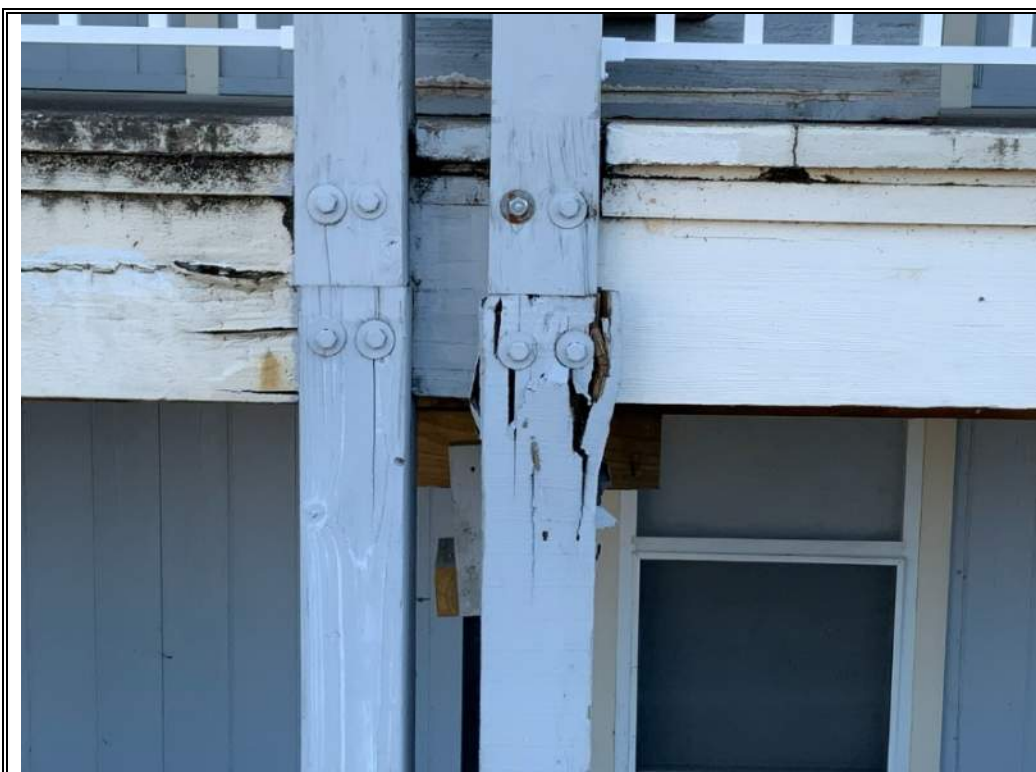
**Photo Number**  
**31**

Deteriorated posts and framing observed at the front of the condominium buildings

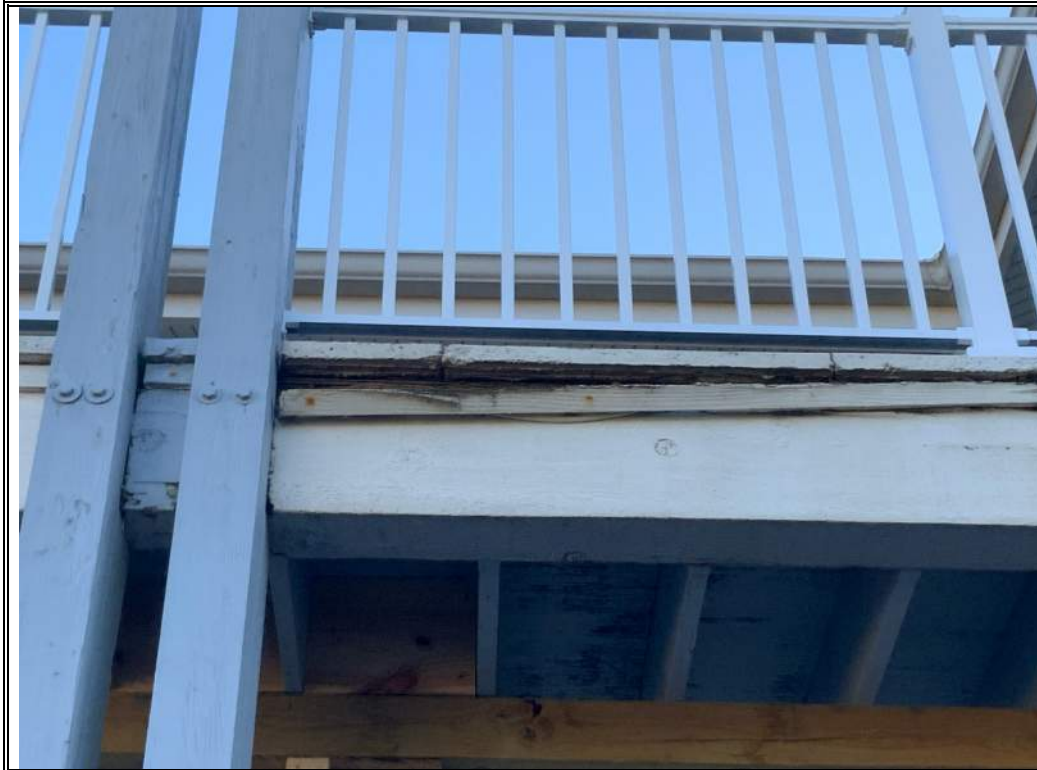
Deteriorated posts and framing observed at the front of the condominium buildings

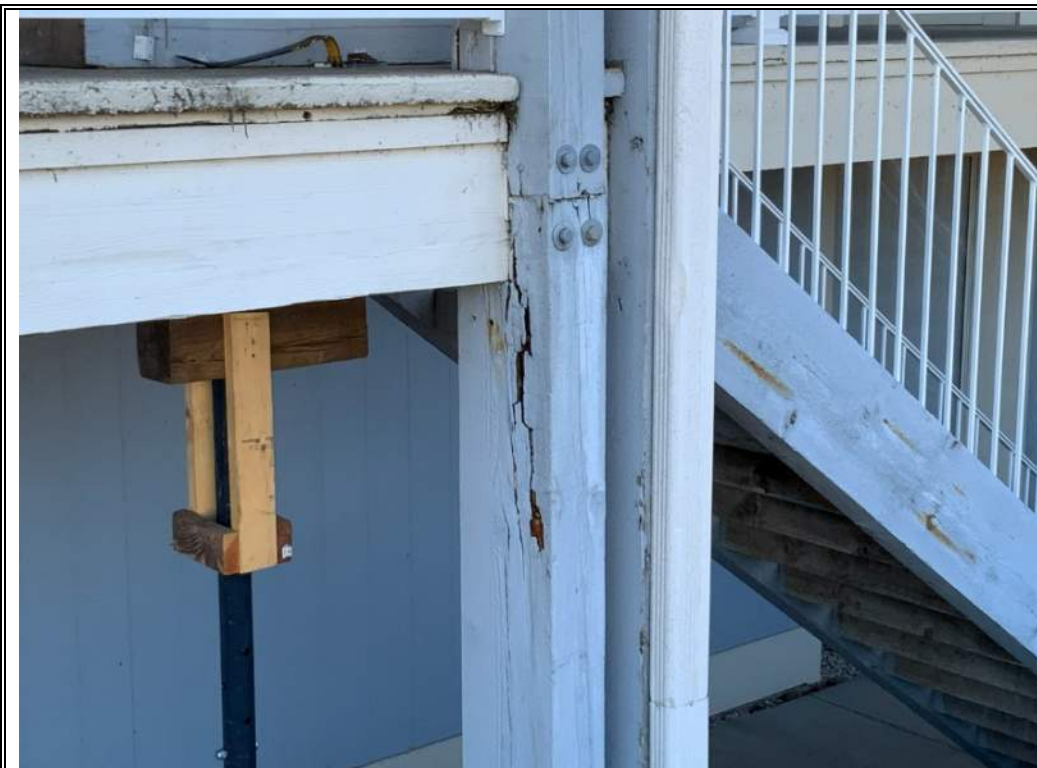
**Photo Number**  
**33**

Deteriorated posts and framing observed at the front of the condominium buildings

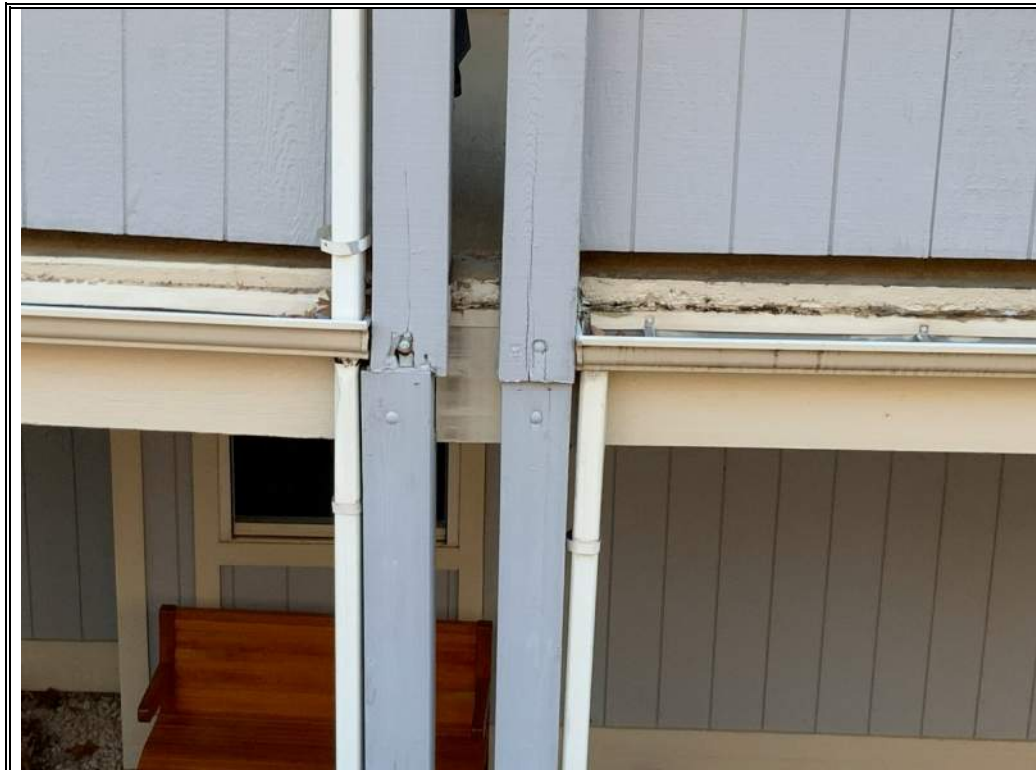
Deteriorated posts  
and framing  
observed at the  
front of the  
condominium  
buildings

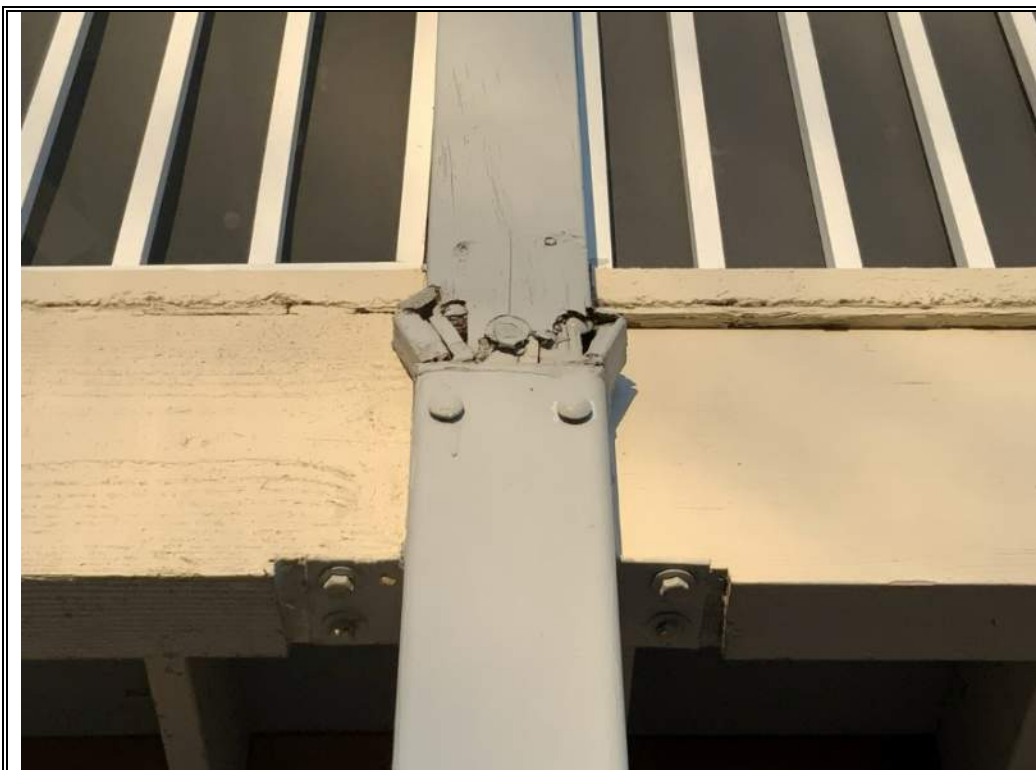
Deteriorated posts  
and framing  
observed at the  
front of the  
condominium  
buildings

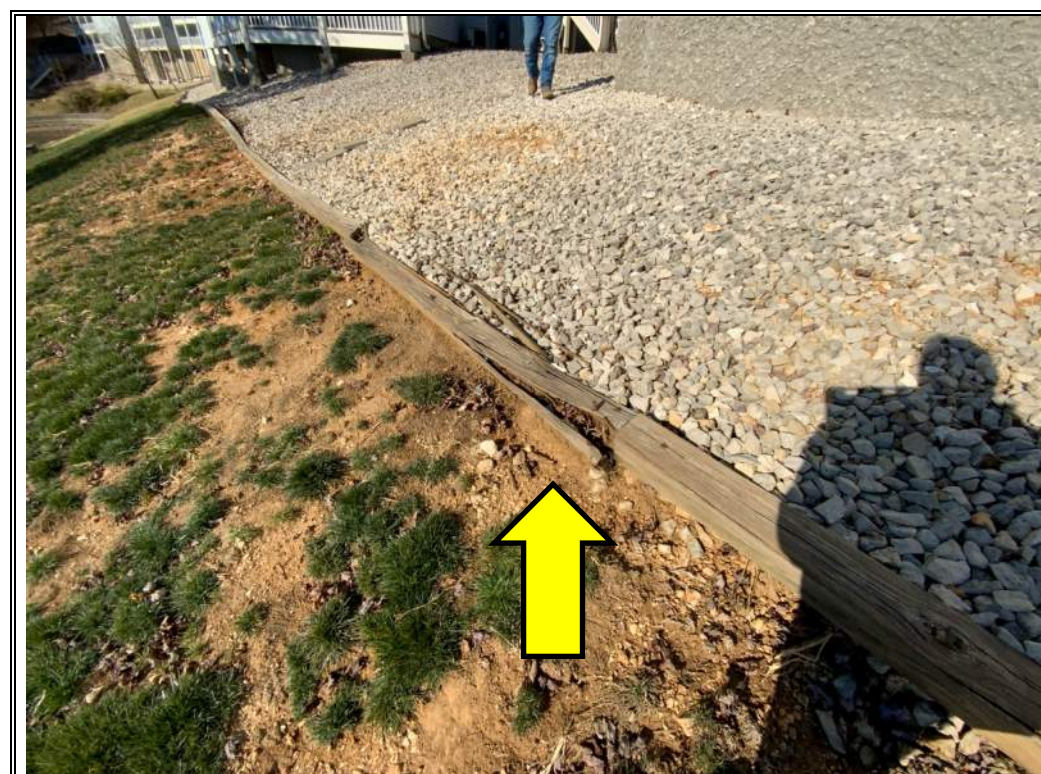
**Photo Number**  
**55**

Deteriorated  
timber at the rear  
of the  
condominium  
buildings

| ASSET N° | NAME | NEXT<br>ACTIVITY | EST<br>LIFE | ADJ<br>LIFE | REM<br>USEFUL<br>LIFE | UNIT<br>COST | QTY | YEAR 1<br>REPLACEMENT<br>COST |
|---|---|---|---|---|---|---|---|---|
| 54 | Replace timber edging at rear of buildings | 01/01/2027 | 15y | 15y | 0y | \$19.28 | 900 LF | \$17,354 |

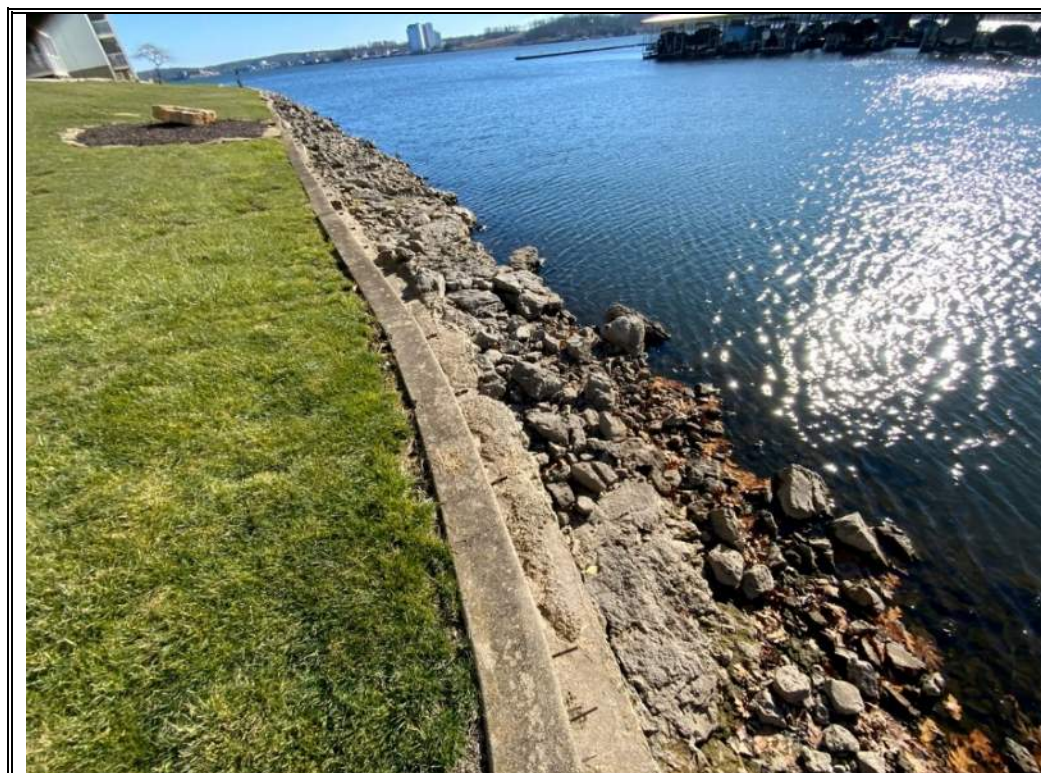
Shoreline at the rear of the buildings in need of rip rap augmentation

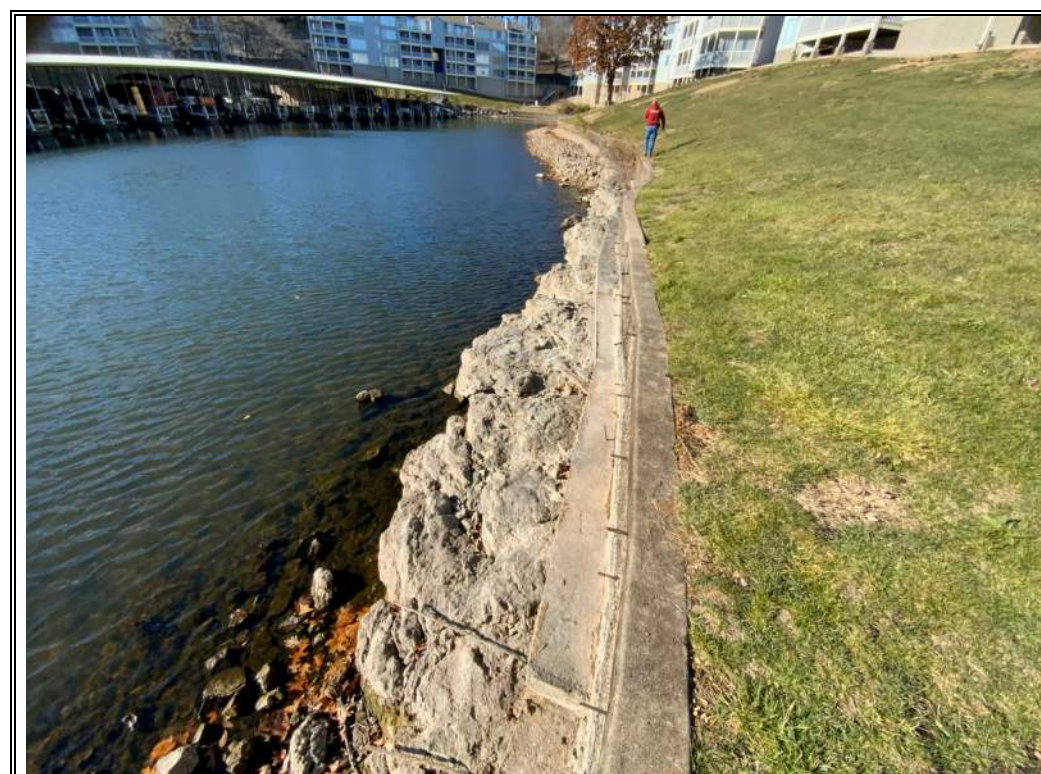
**Photo Number**  
**57**

Shoreline at the rear of the buildings in need of rip rap augmentation

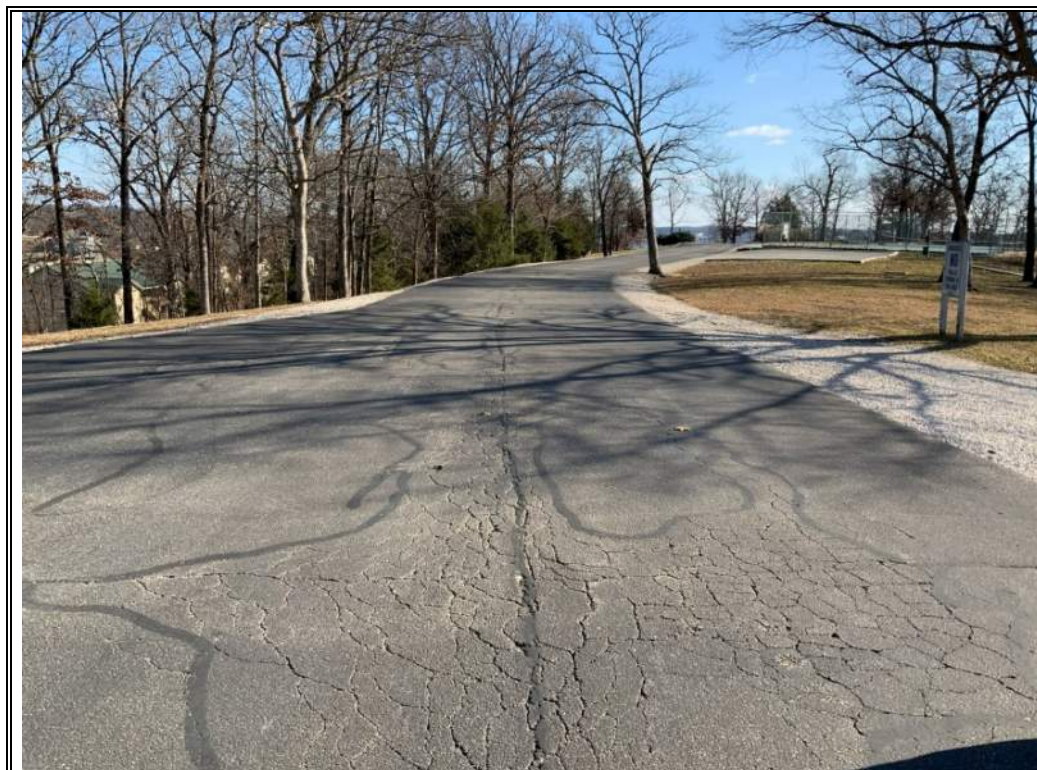
**Photo Number**  
**65**

“Alligator”  
cracking and  
deterioration

| ASSET N° | NAME | NEXT<br>ACTIVITY | EST<br>LIFE | ADJ<br>LIFE | REM<br>USEFUL<br>LIFE | UNIT<br>COST | QTY | YEAR 1<br>REPLACEMENT<br>COST |
|---|---|---|---|---|---|---|---|---|
| 58 | Full depth repairs of sections of asphalt surfaces | 01/01/2029 | 5y | 5y | 2y | \$91.05 | 514.32 SY | \$46,831 |

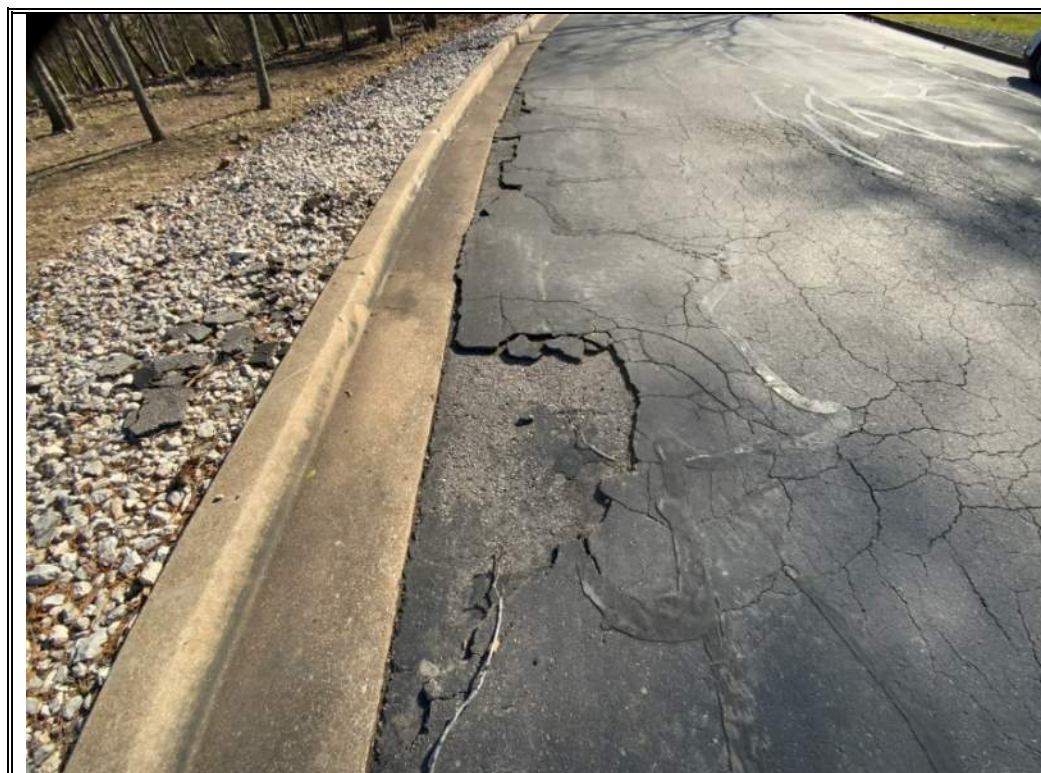
Asphalt  
deterioration  
observed near the  
entrance  
monument

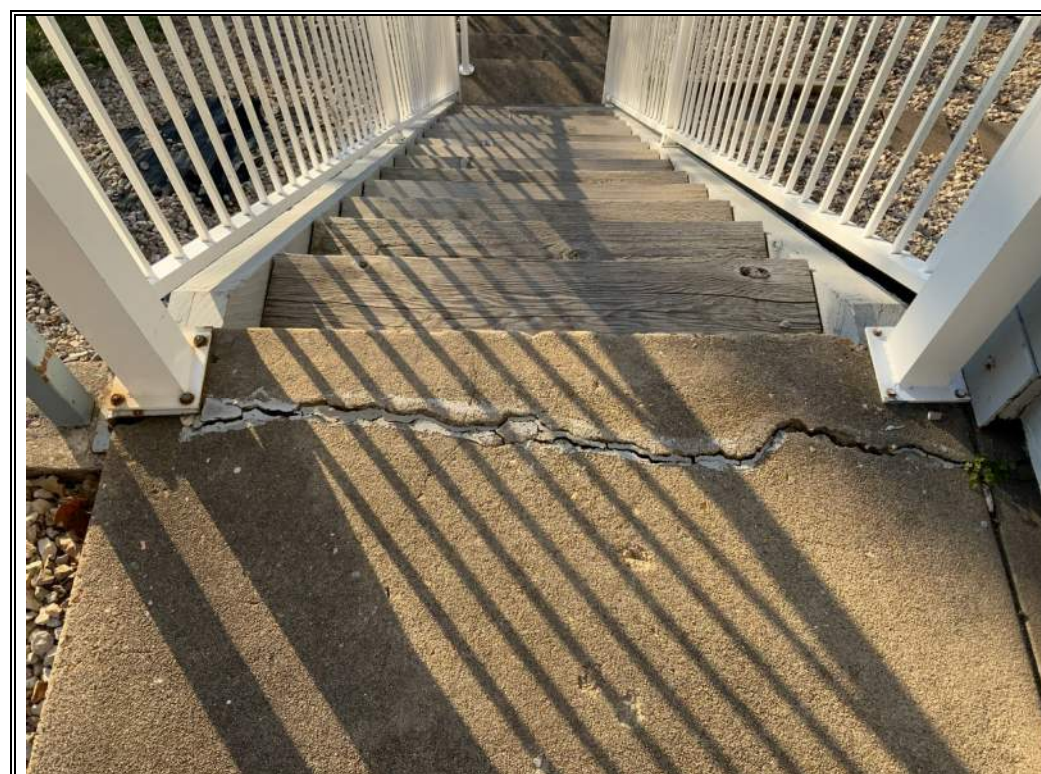
**Photo Number**  
**67**

Typical cracking  
observed in the  
concrete walkways

| ASSET Nº | NAME | NEXT<br>ACTIVITY | EST<br>LIFE | ADJ<br>LIFE | REM<br>USEFUL<br>LIFE | UNIT<br>COST | QTY | YEAR 1<br>REPLACEMENT<br>COST |
|---|---|---|---|---|---|---|---|---|
| 65 | Repair sections of concrete flatwork | 01/01/2028 | 4y | 4y | 1y | \$230.31 | 190 SY | \$43,759 |

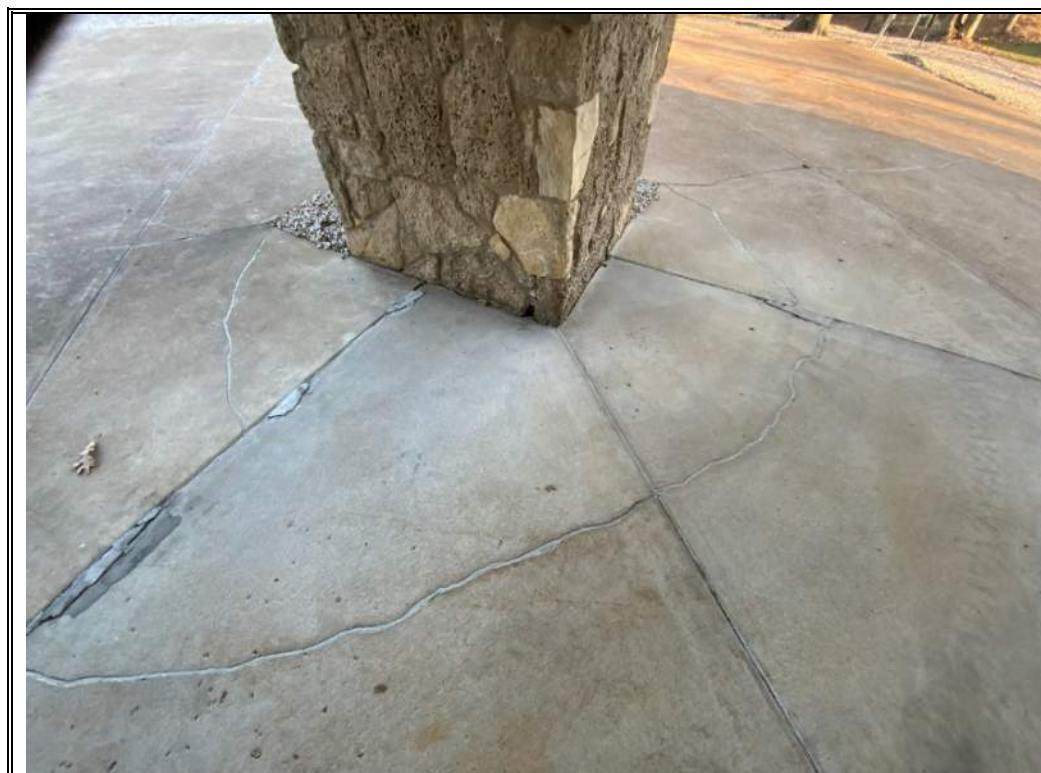
Typical cracking  
observed in the  
concrete walkways

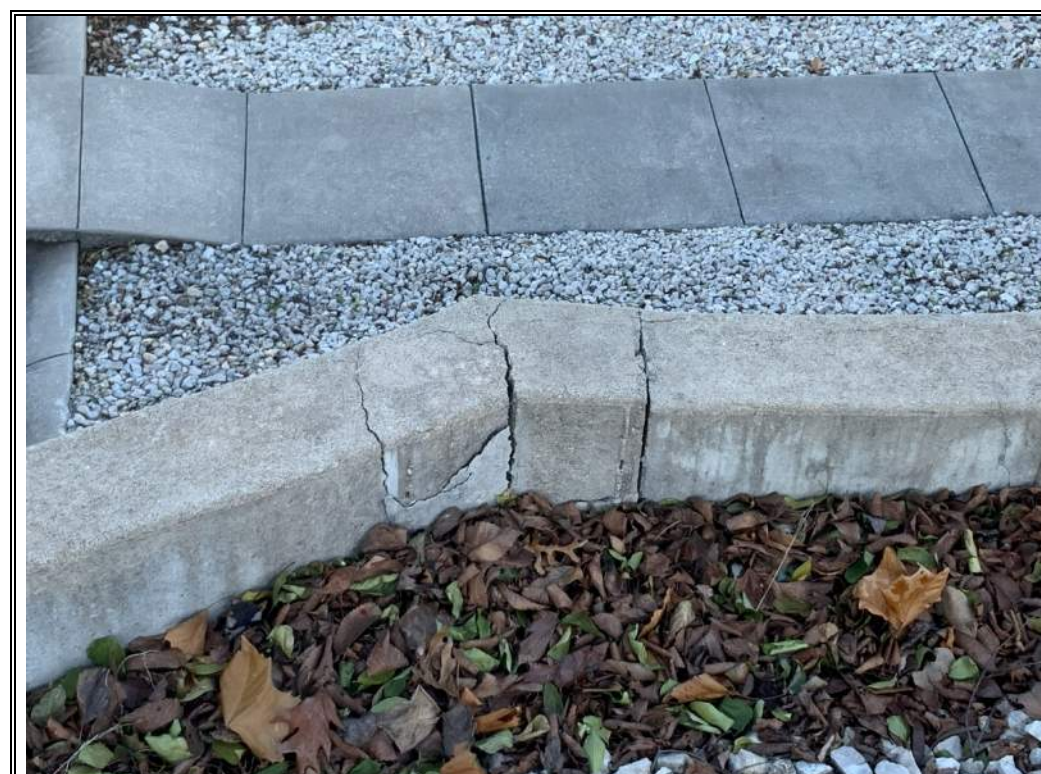
**Photo Number**  
**69**

Stress fracturing at  
the corner of a  
concrete retaining  
wall

| ASSET Nº | NAME | NEXT<br>ACTIVITY | EST<br>LIFE | ADJ<br>LIFE | REM<br>USEFUL<br>LIFE | UNIT<br>COST | QTY | YEAR 1<br>REPLACEMENT<br>COST |
|---|---|---|---|---|---|---|---|---|
| 66 | Allocation for unplanned repairs to concrete retaining walls | 01/01/2037 | 10y | 10y | 10y | \$42,849.00 | 1 Allow | \$42,849 |

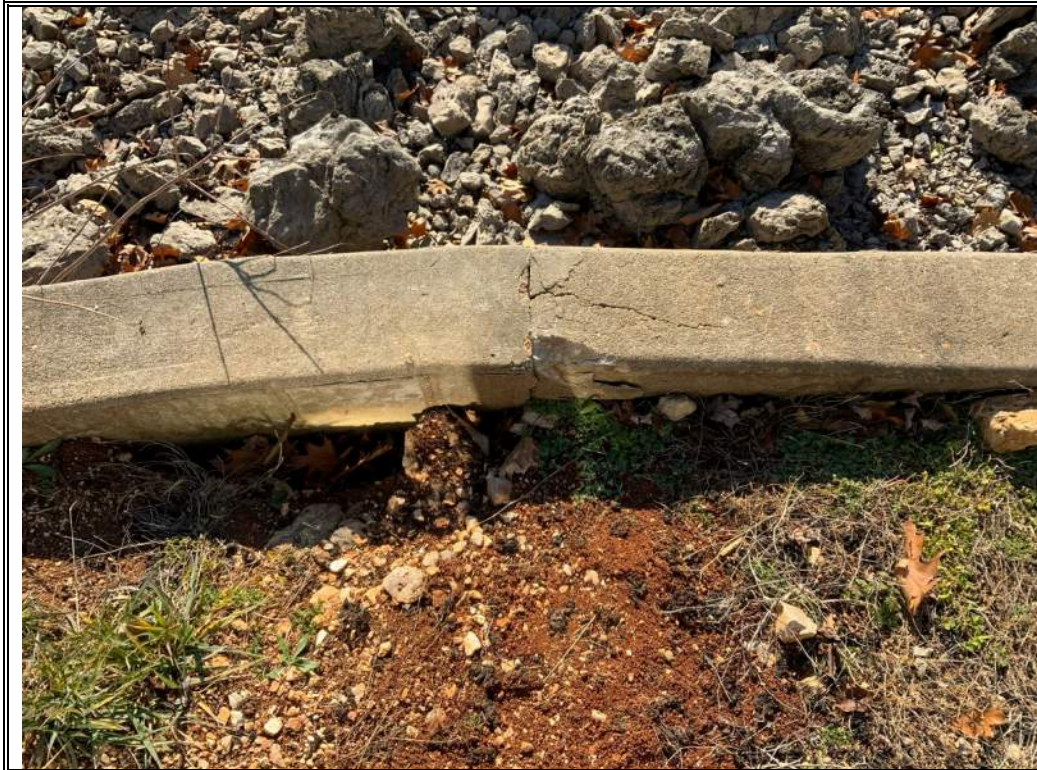
Stress fracturing at  
the corner of a  
concrete retaining  
wall

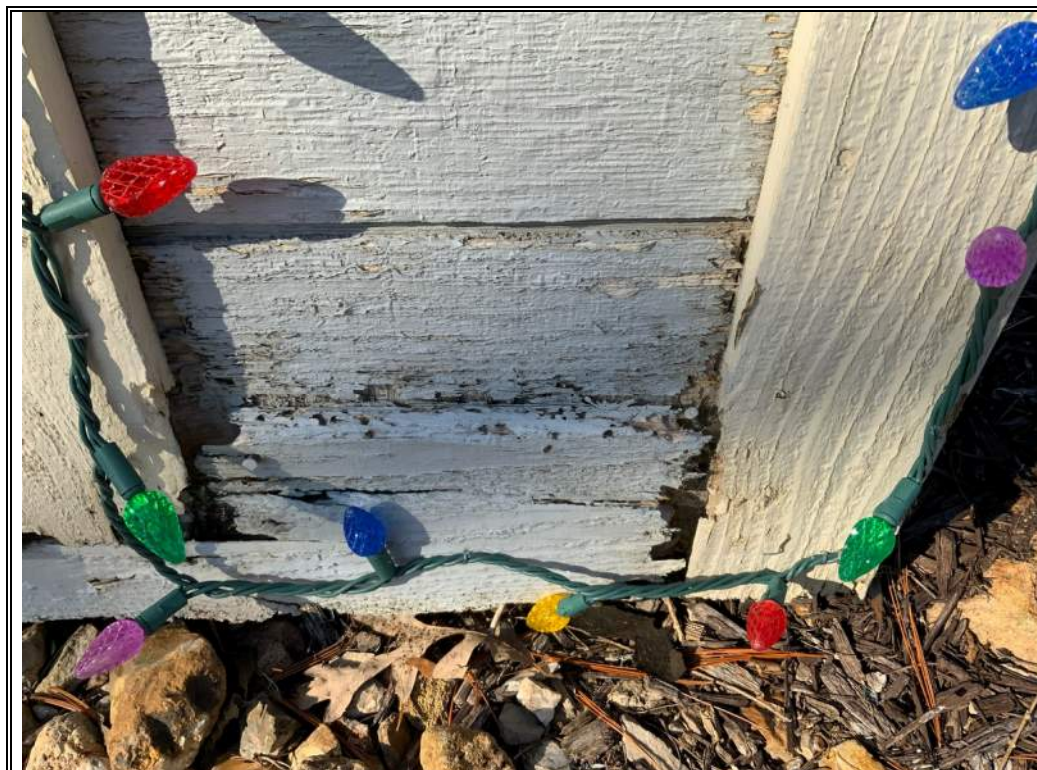
**77**

Deterioration  
observed on the  
exterior surfaces of  
the entrance  
monument

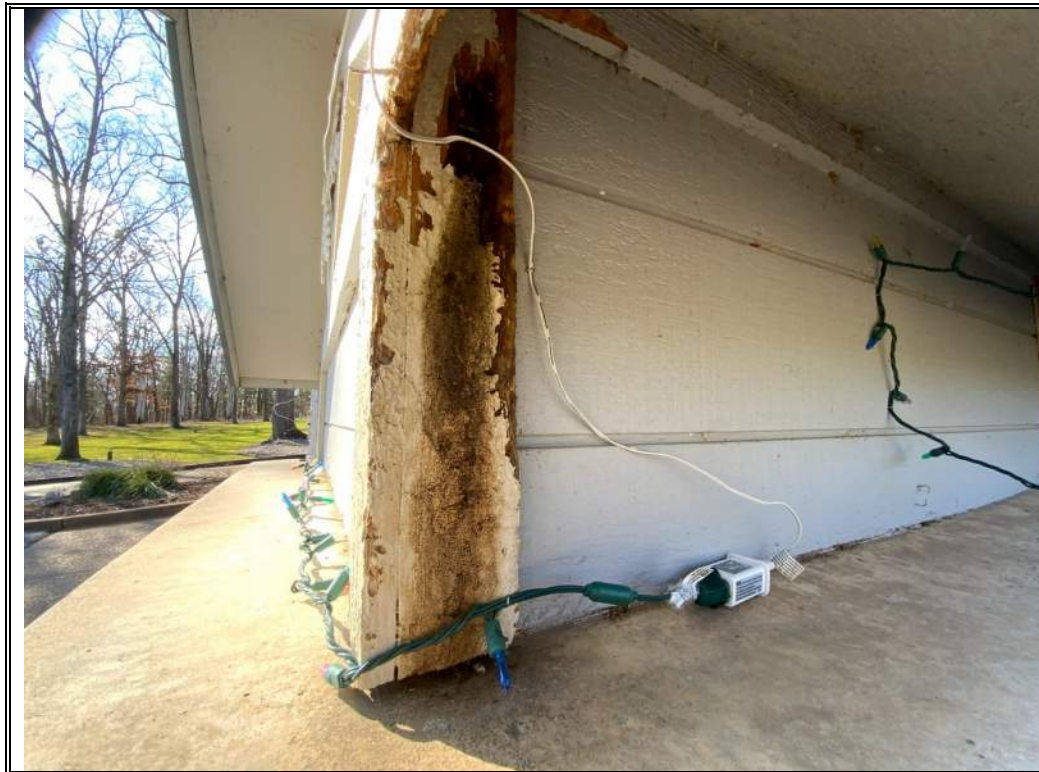
Deterioration  
observed on the  
exterior surfaces of  
the entrance  
monument

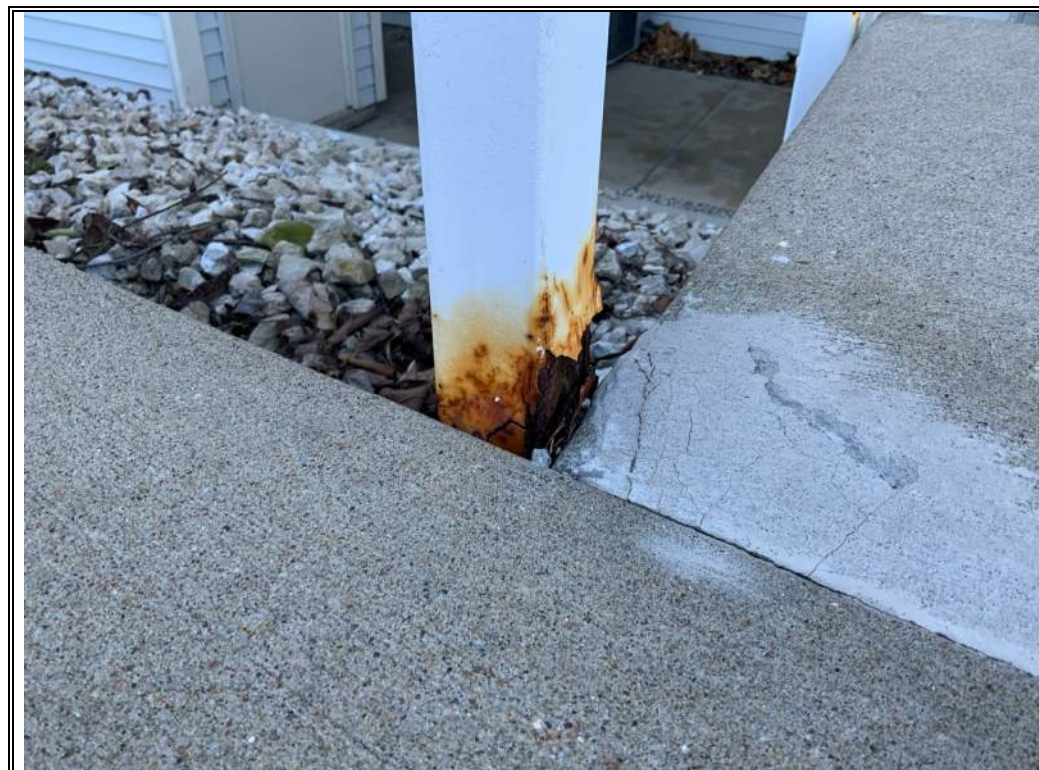
**Photo Number**  
**79**

Deterioration  
observed at the  
base of a metal  
railing

| ASSET Nº | NAME | NEXT<br>ACTIVITY | EST<br>LIFE | ADJ<br>LIFE | REM<br>USEFUL<br>LIFE | UNIT<br>COST | QTY | YEAR 1<br>REPLACEMENT<br>COST |
|---|---|---|---|---|---|---|---|---|
| 69 | Replace site railings | 01/01/2030 | 3y | 3y | 3y | \$42,849.00 | 1 LF | \$42,849 |

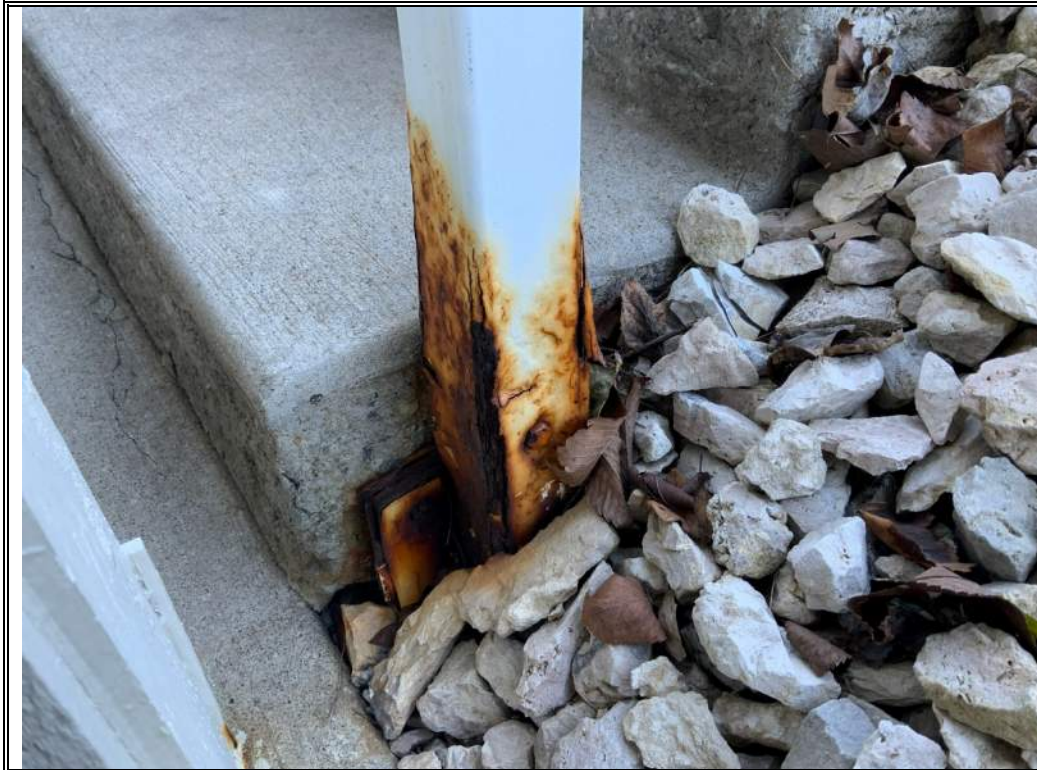
Deterioration  
observed at the  
base of a metal  
railing
