Via Email: *sample@sample.com*  
Property: **Sample Condominiums**  
**123 Sample Rd, Sample, 12345**

Service: **FULL RESERVE STUDY**

Project No.: 202511-10

Site Inspection performed December 10, 2025  
*Submitted February 2, 2026*

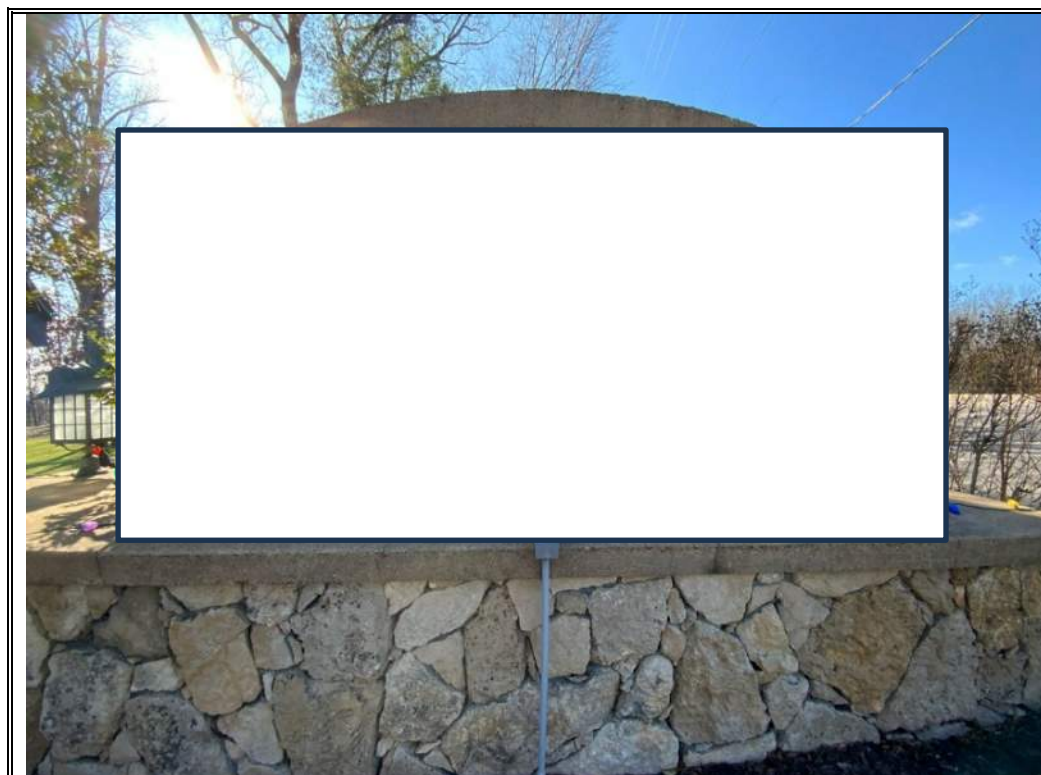
Entrance  
monument to the  
Sample  
Condominiums  
Community

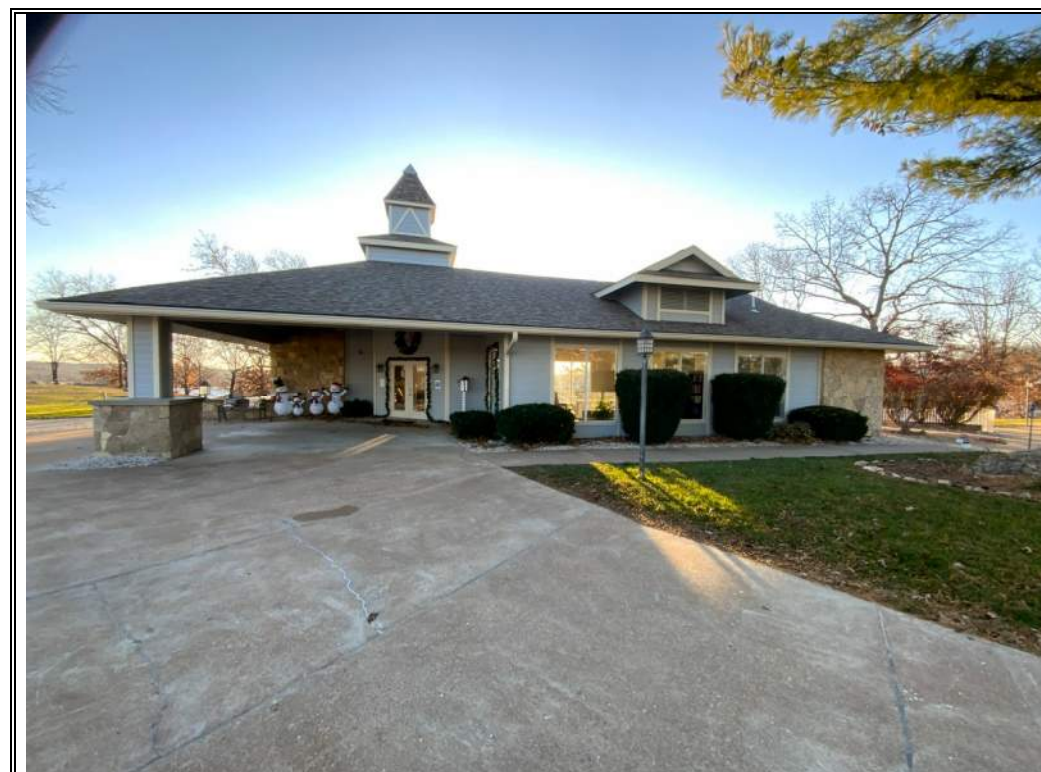
**Photo Number**  
**1**

Community  
clubhouse

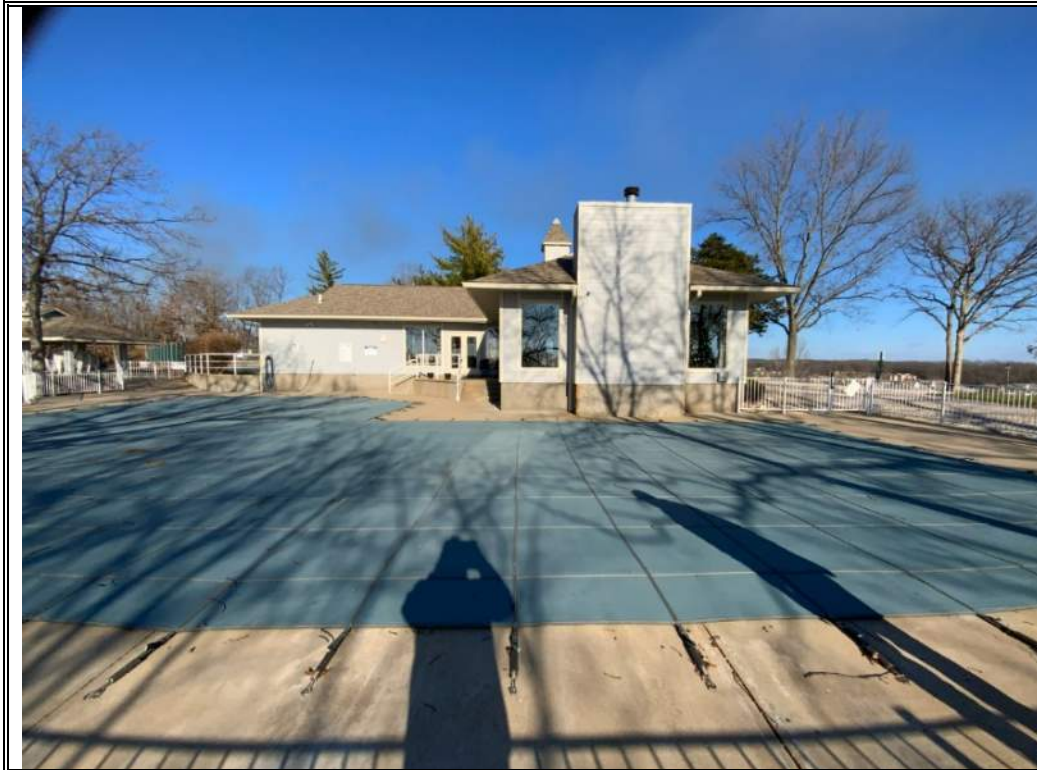
View of the rear of  
the clubhouse and  
outdoor pool

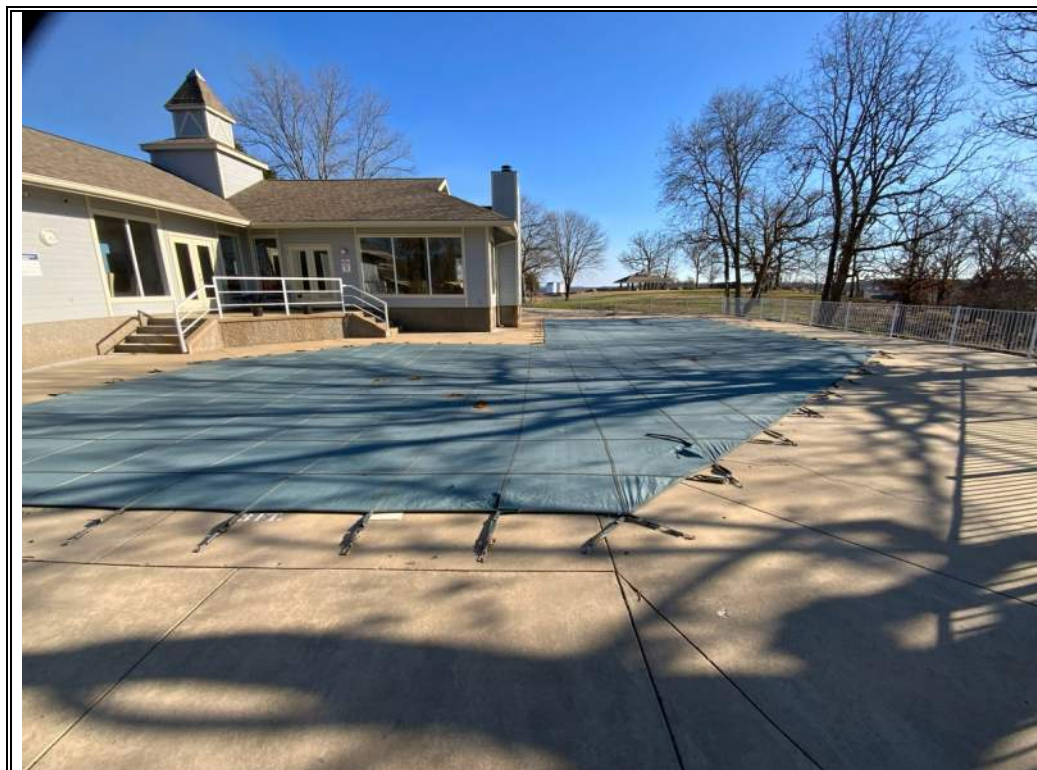
**7**

View of the upper  
pool

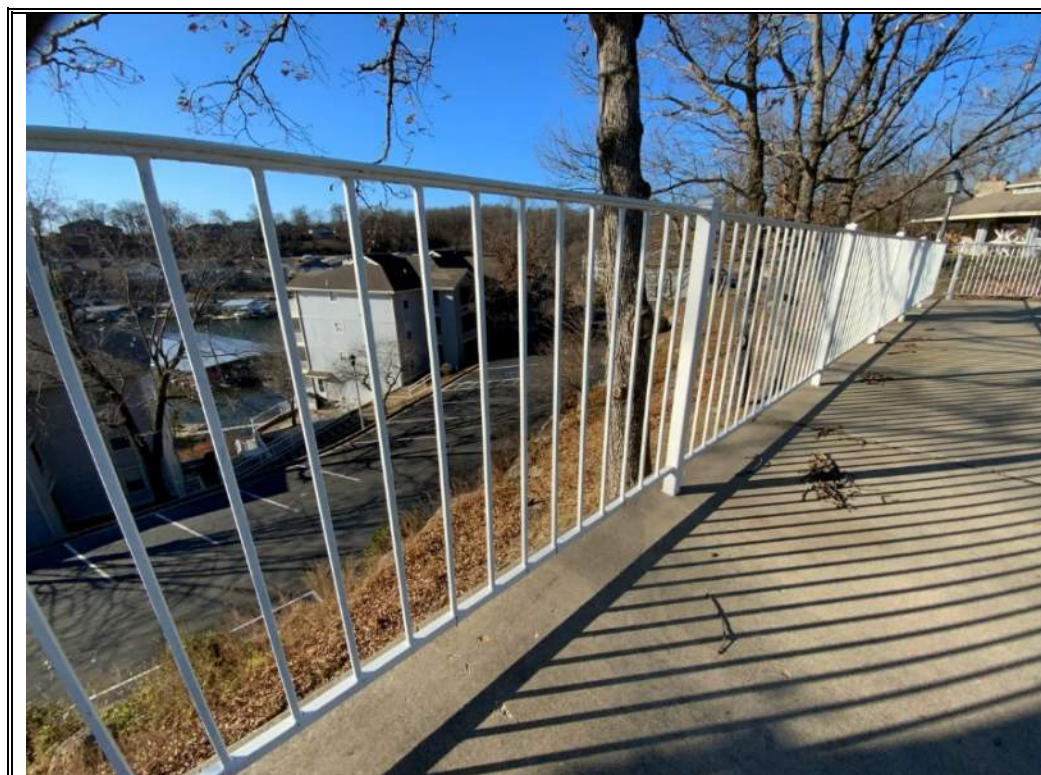
Pool fencing

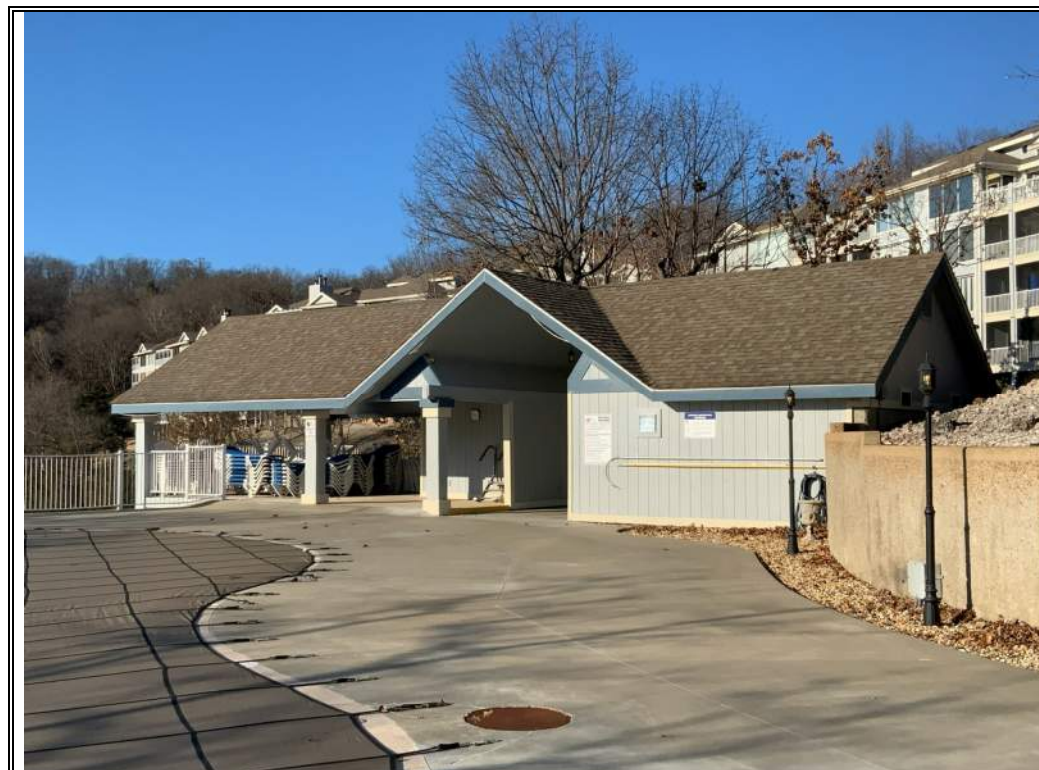
**Photo Number**  
**13**

View of the lower  
pool house

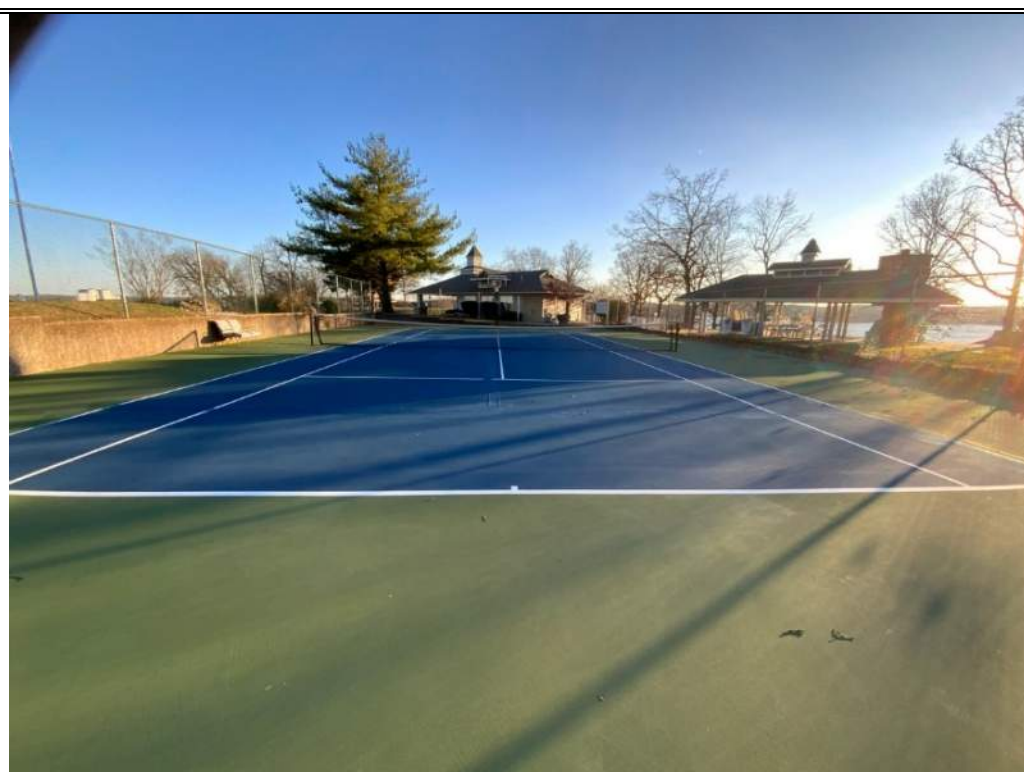
**Photo Number**  
**21**

Lower tennis  
courts

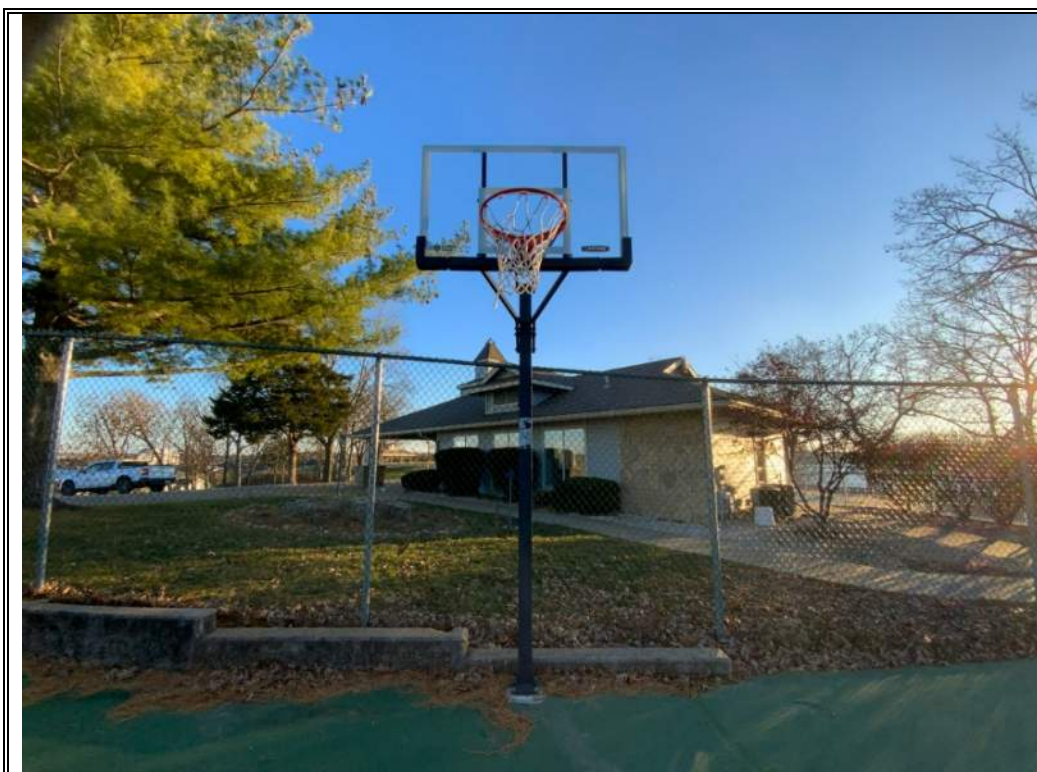
**Photo Number**  
**23**

Basketball hoop  
installed at the  
lower tennis courts

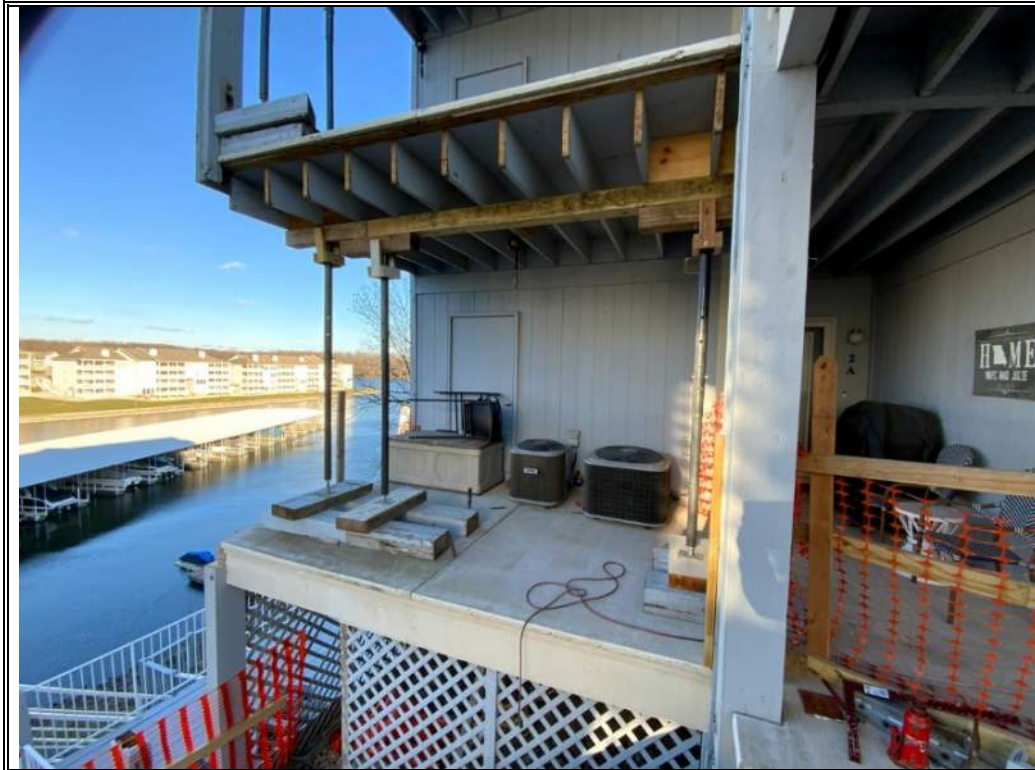
Repairs underway  
on a walkway at  
the front of a  
condominium  
building

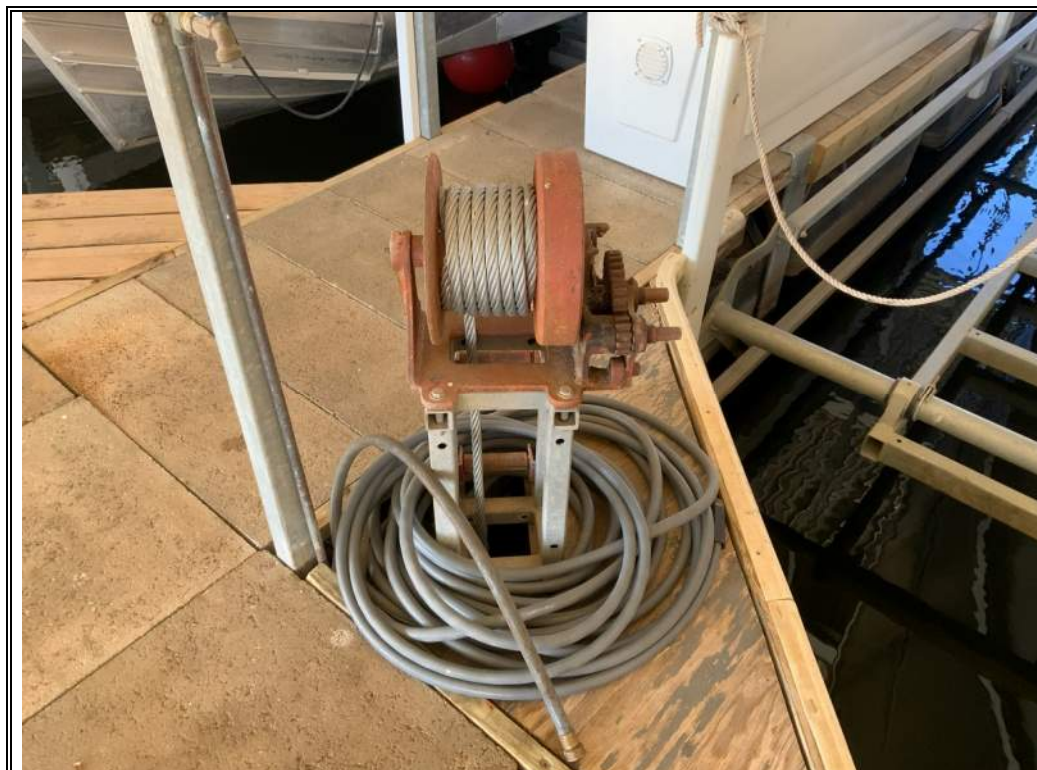
**Photo Number**  
**43**

Typical winch and  
anchor cable

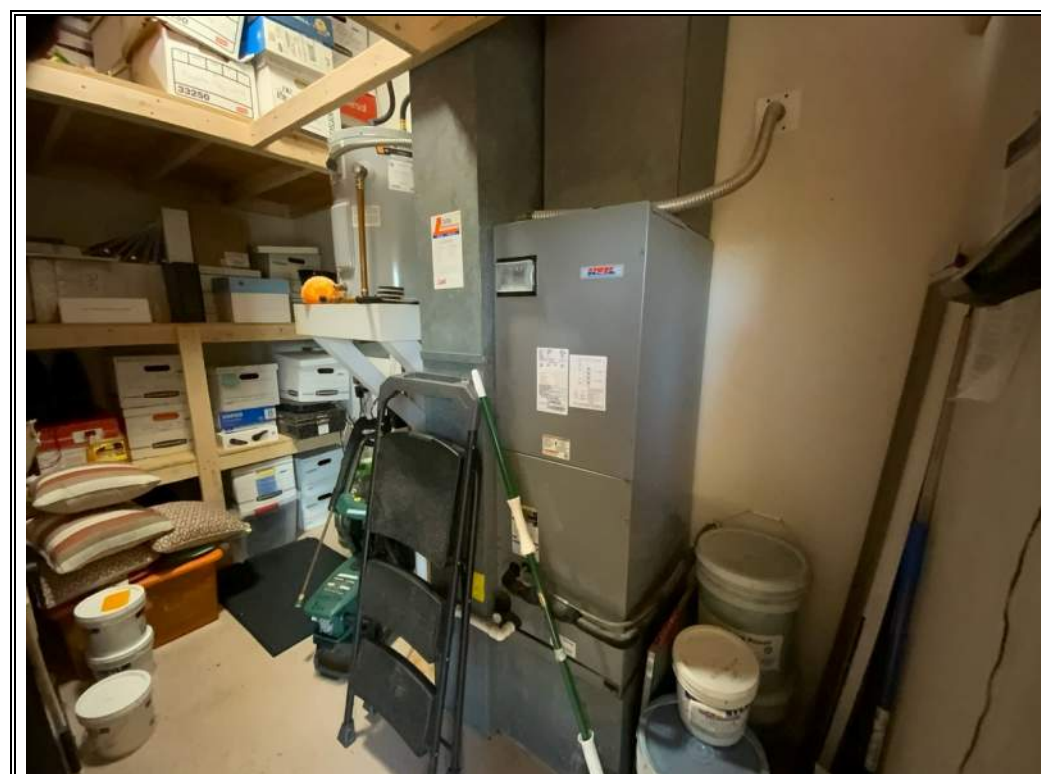
**Photo Number**  
**47**

Clubhouse air  
handler

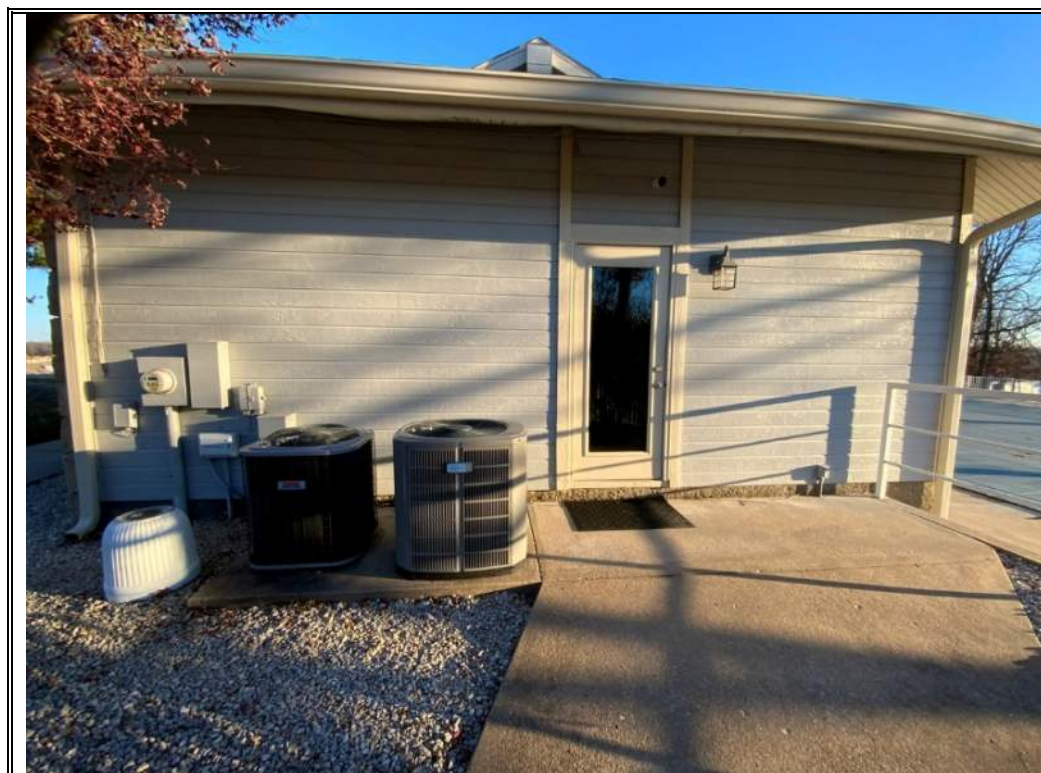
Clubhouse  
condensers

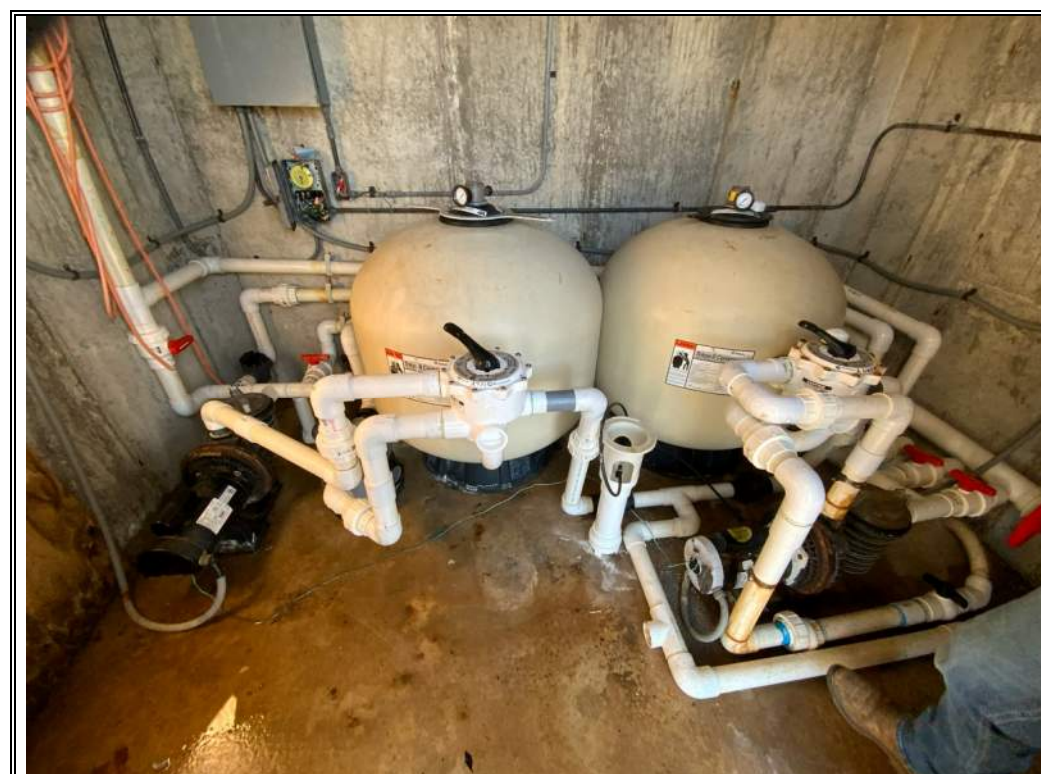
**Photo Number**  
**49**

Pool pumps and  
filters for the  
upper pool

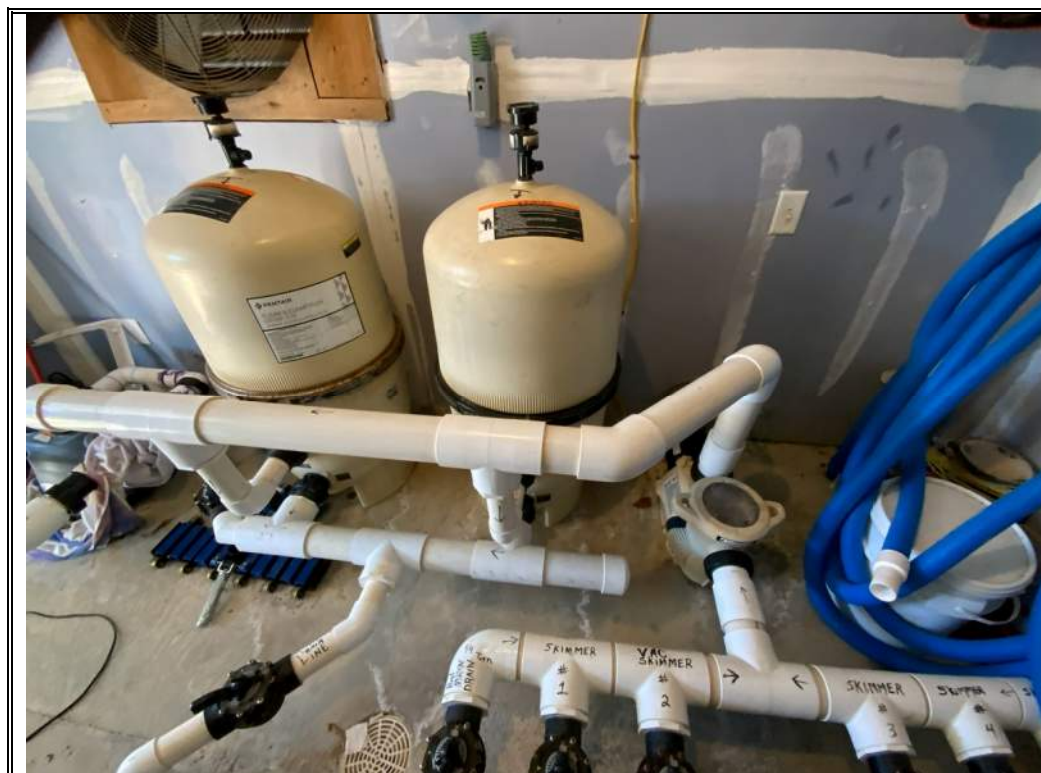
Pool pumps and  
filters for the lower  
pool

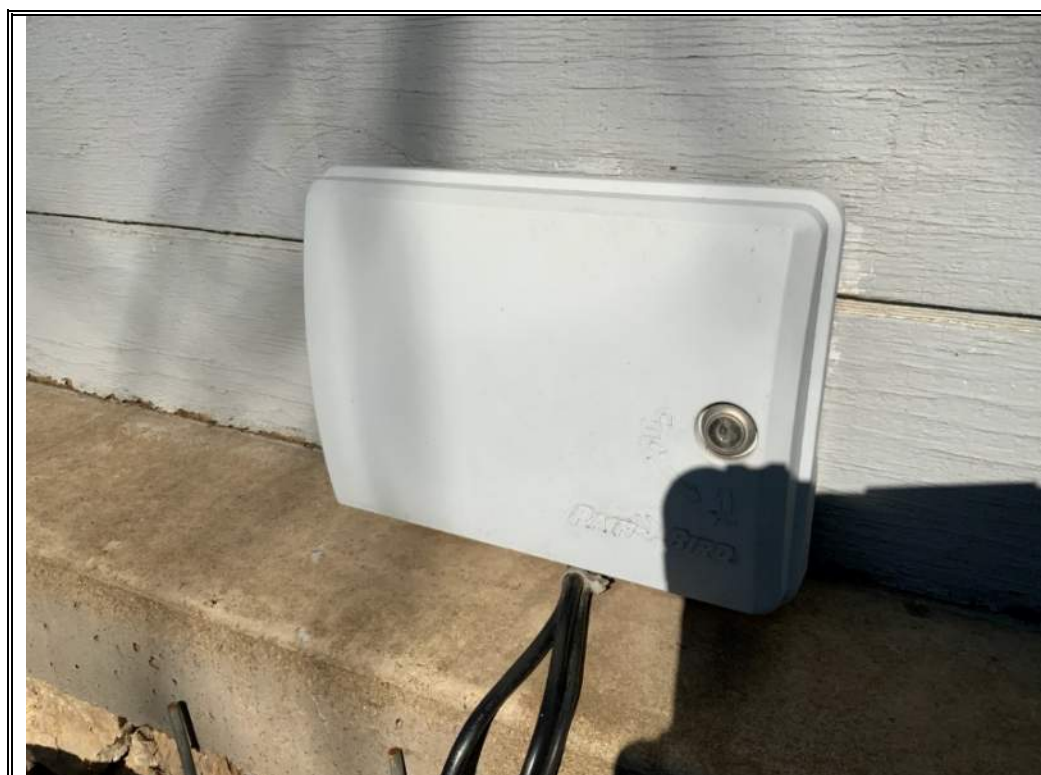
Typical irrigation  
control box

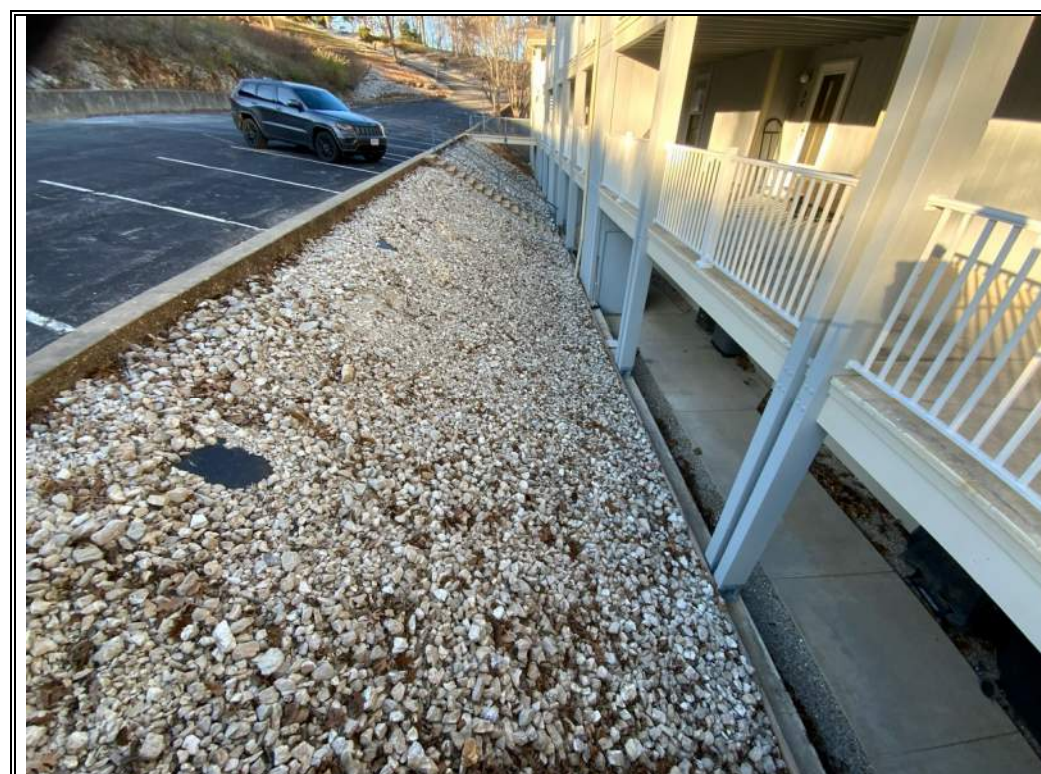
**Photo Number**  
**59**

Drainage piping  
project at the front  
of the buildings

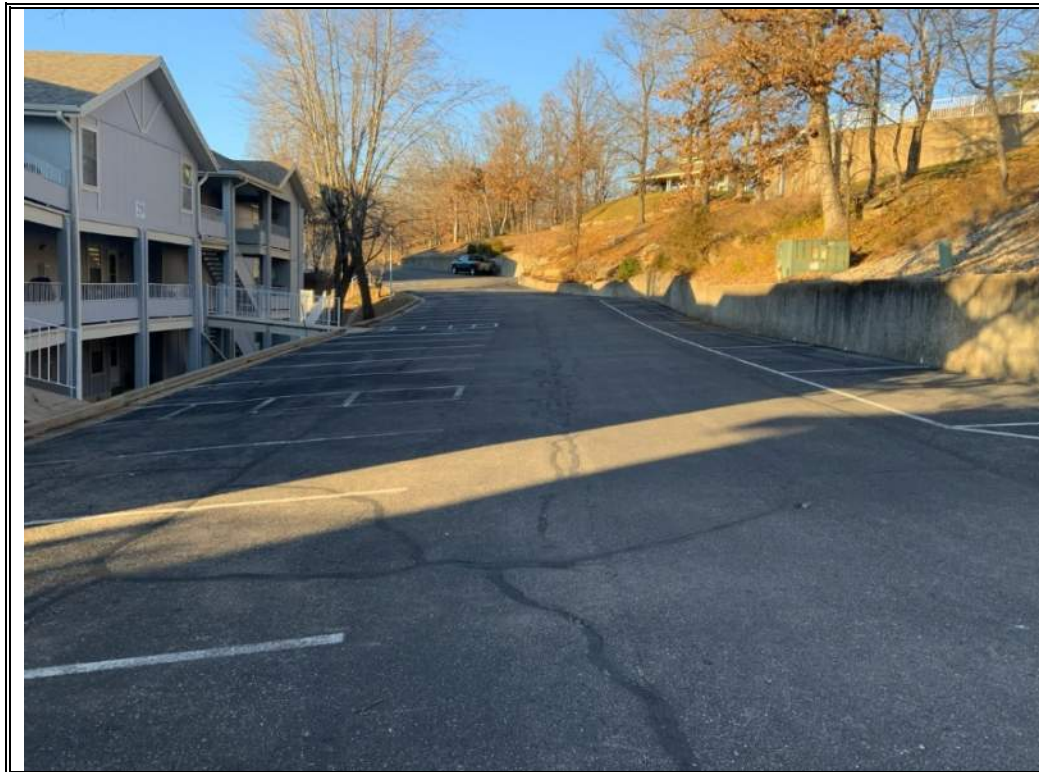
Typical view of  
the asphalt drives  
and parking lots

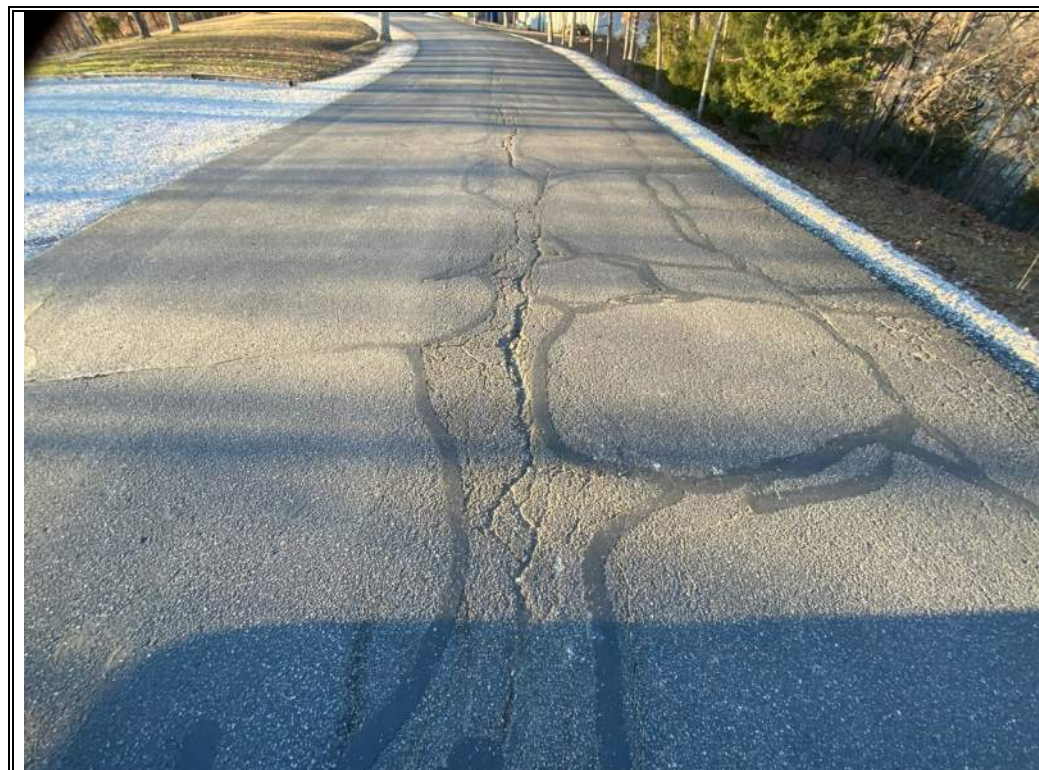
**Photo Number**  
**61**

Typical view of  
the asphalt drives  
and parking lots

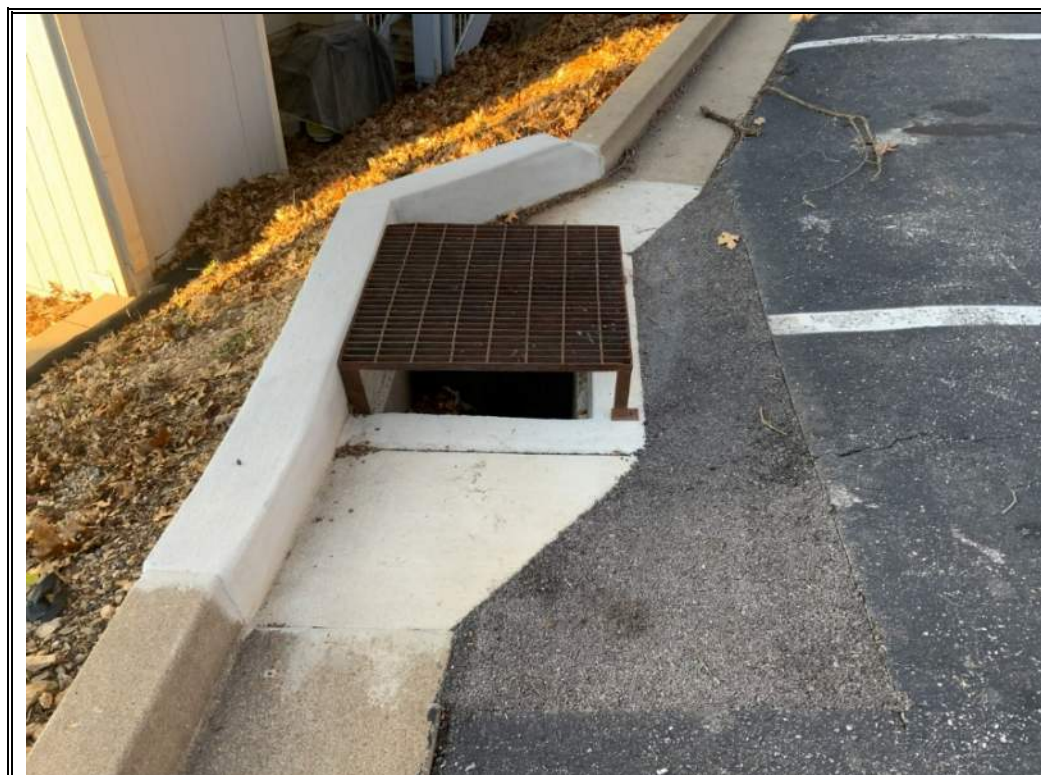
Recently replaced  
paved catch basin

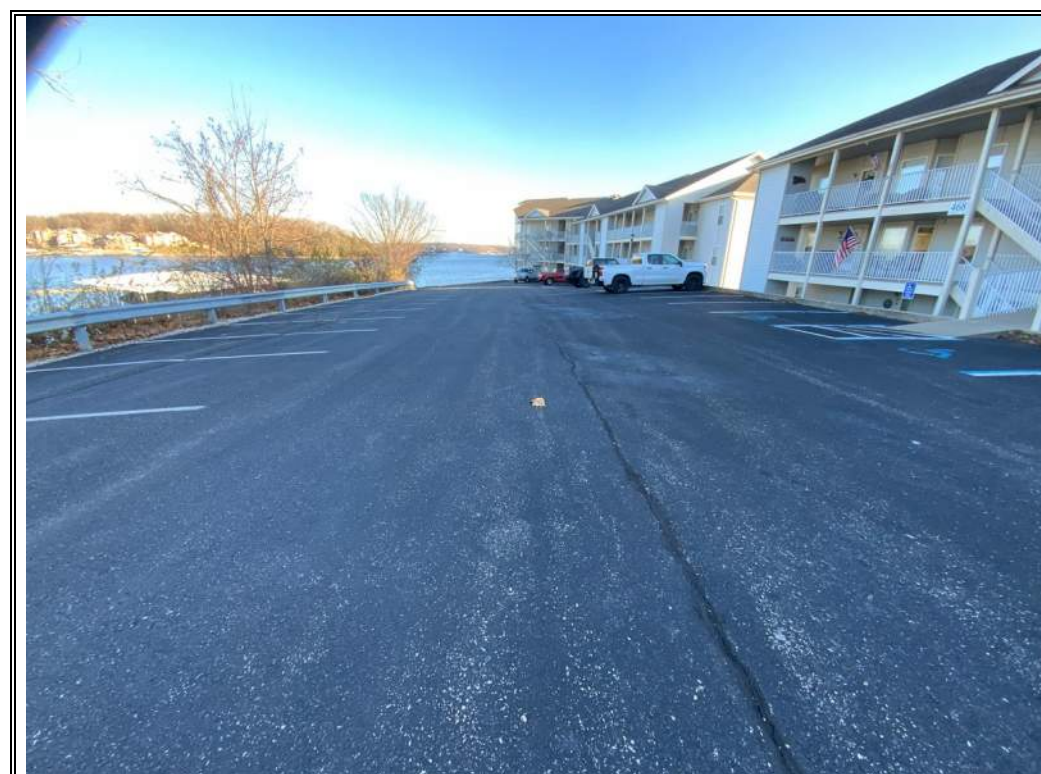
**Photo Number**  
**63**

Typical view of  
the asphalt drives  
and parking lots

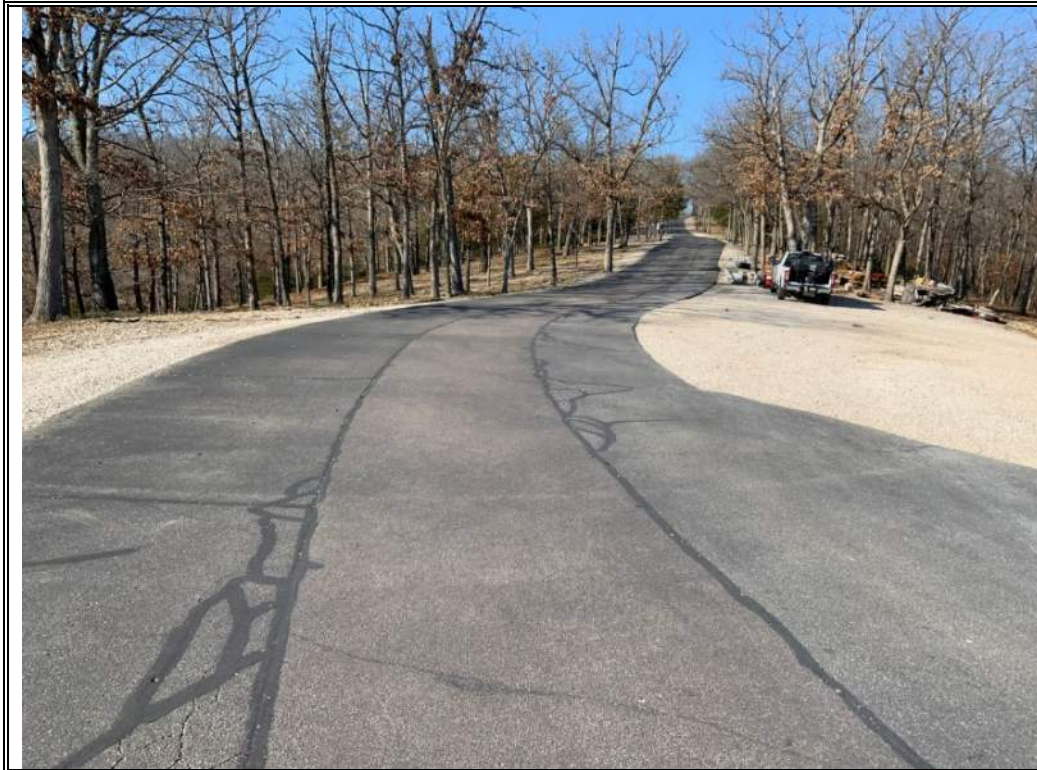
Typical view of  
the asphalt drives  
and parking lots

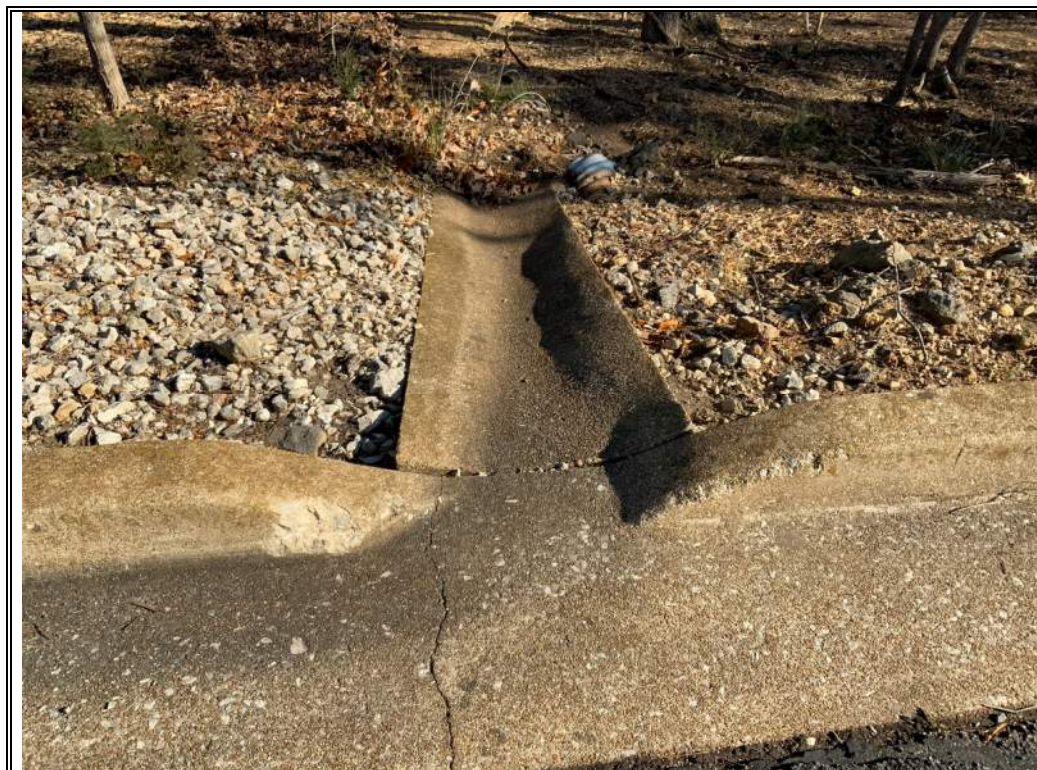
**71**

Typical paved  
drainage swale

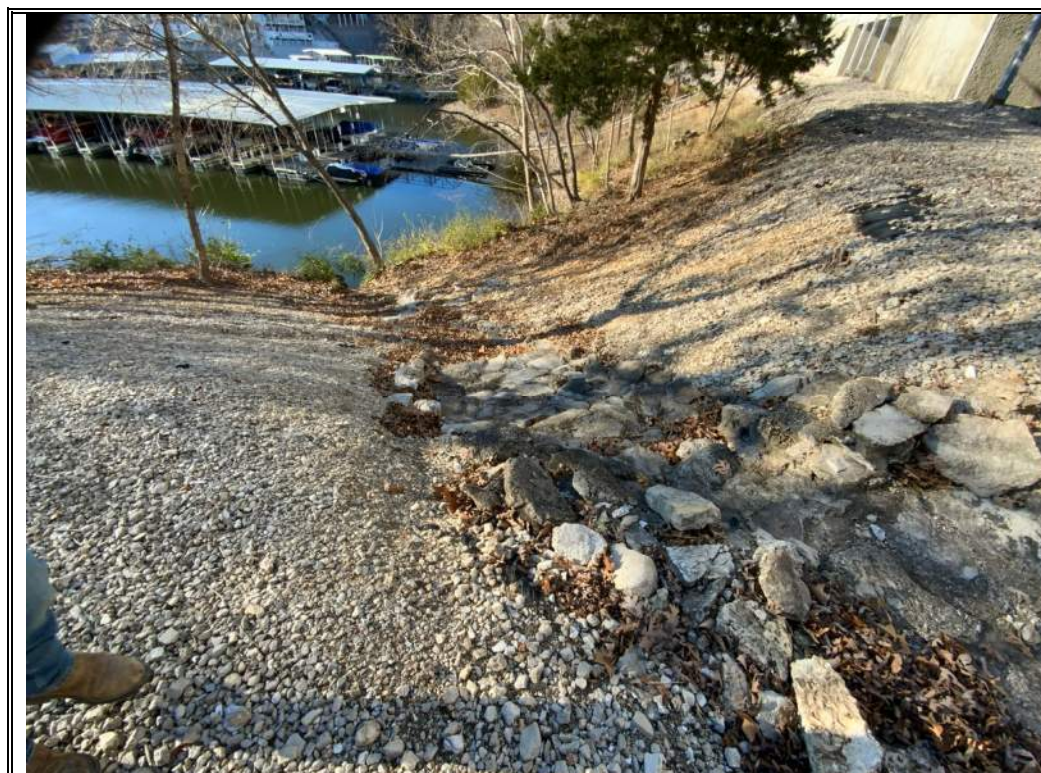
Typical drainage  
swale

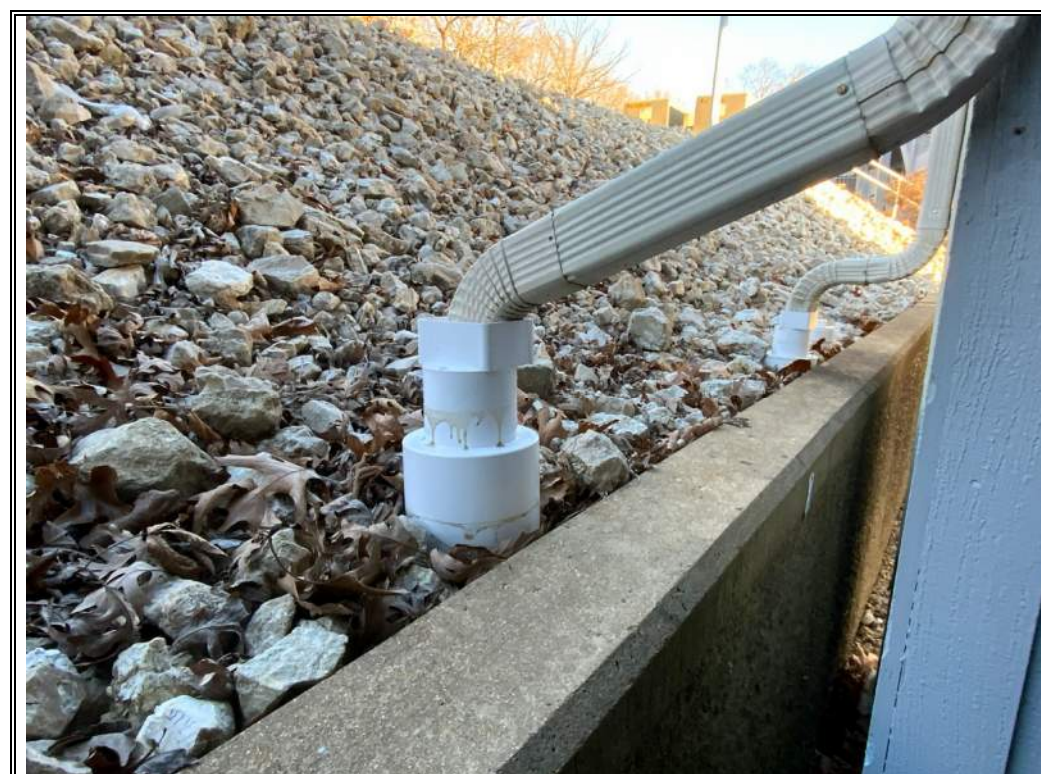
**Photo Number**  
**73**

Typical buried  
downspout piping

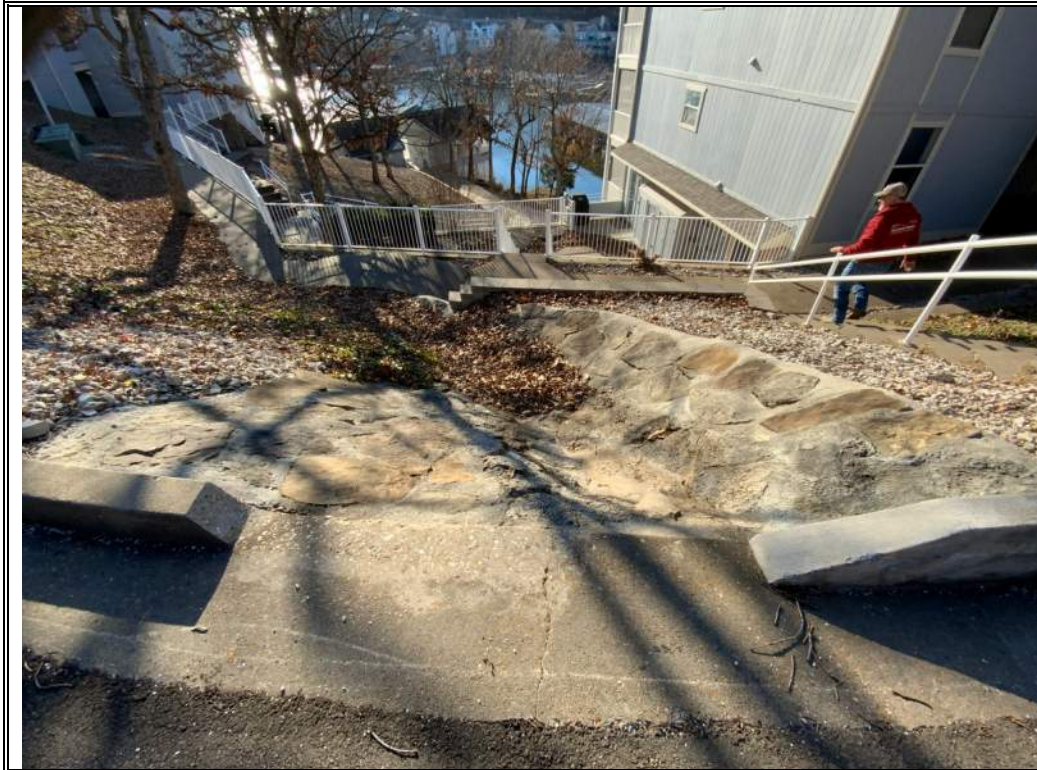
Typical drainage  
swale

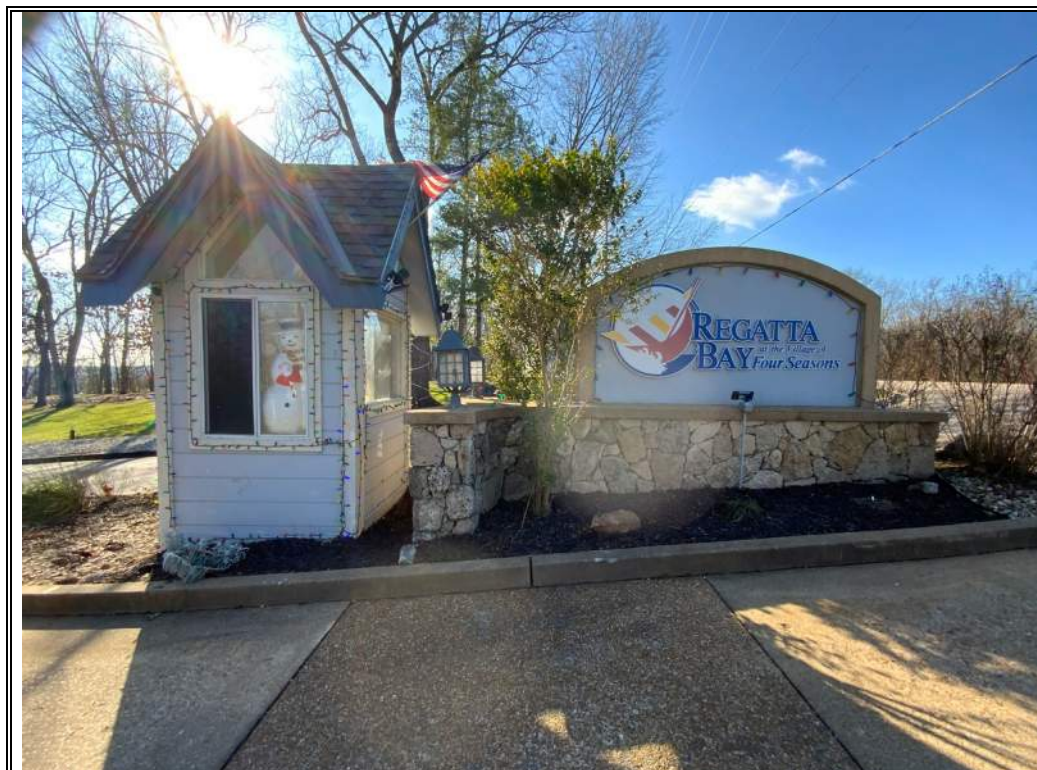
**Photo Number**  
**75**

Entrance  
monument and  
decorative guard  
shack

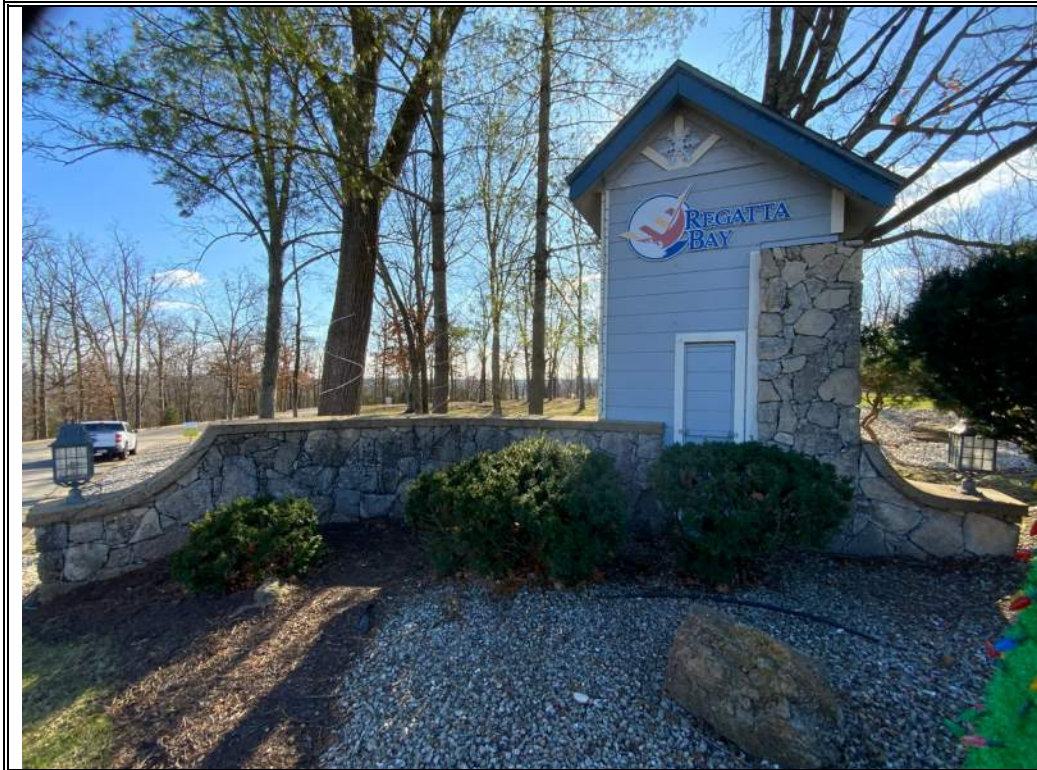
Entrance  
monument stone  
wall and  
decorative building

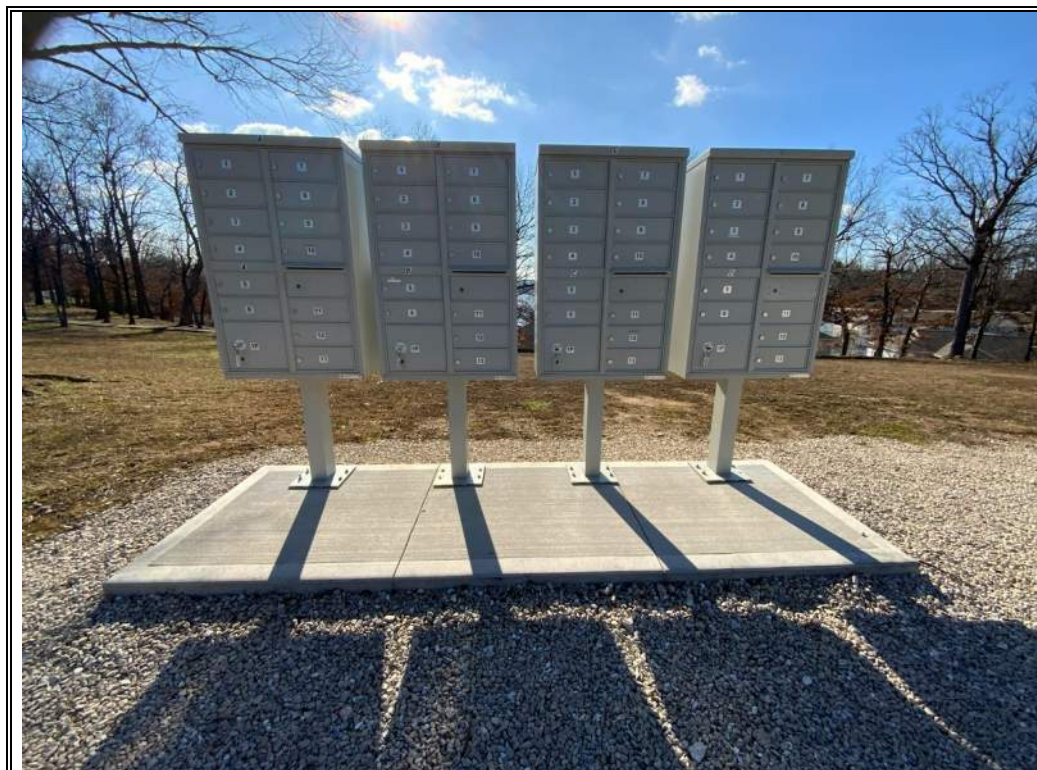
**Photo Number**  
**81**

New mailboxes
