Via Email: *sample@sample.com*  
Property: **Sample Condominiums**  
**123 Sample Rd, Sample, 12345**

Service: **FULL RESERVE STUDY**

Project No.: 202511-10

Site Inspection performed December 10, 2025  
*Submitted February 2, 2026*

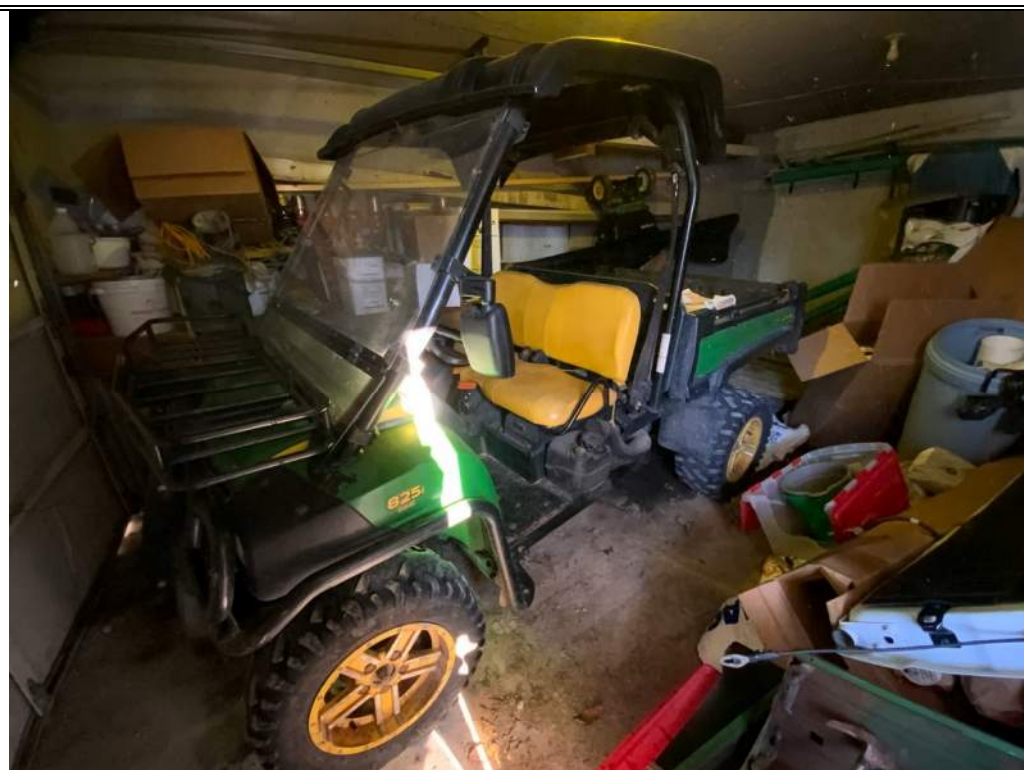
Gator UTV

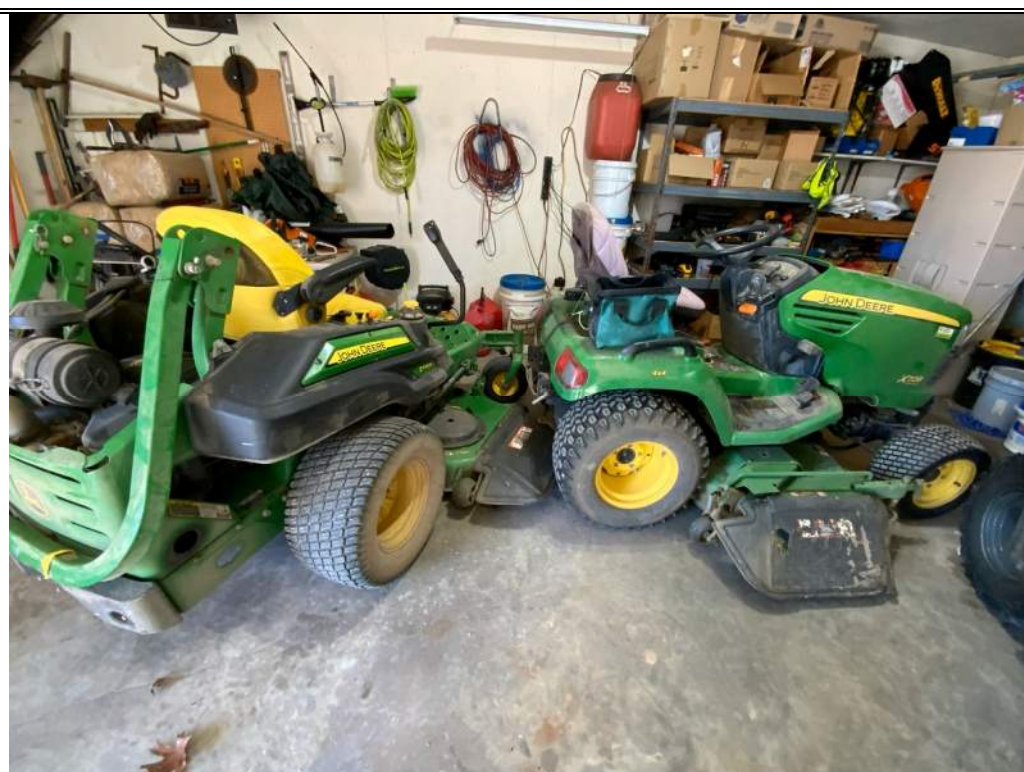
**Photo Number**  
**83**

Maintenance lawn  
mowers

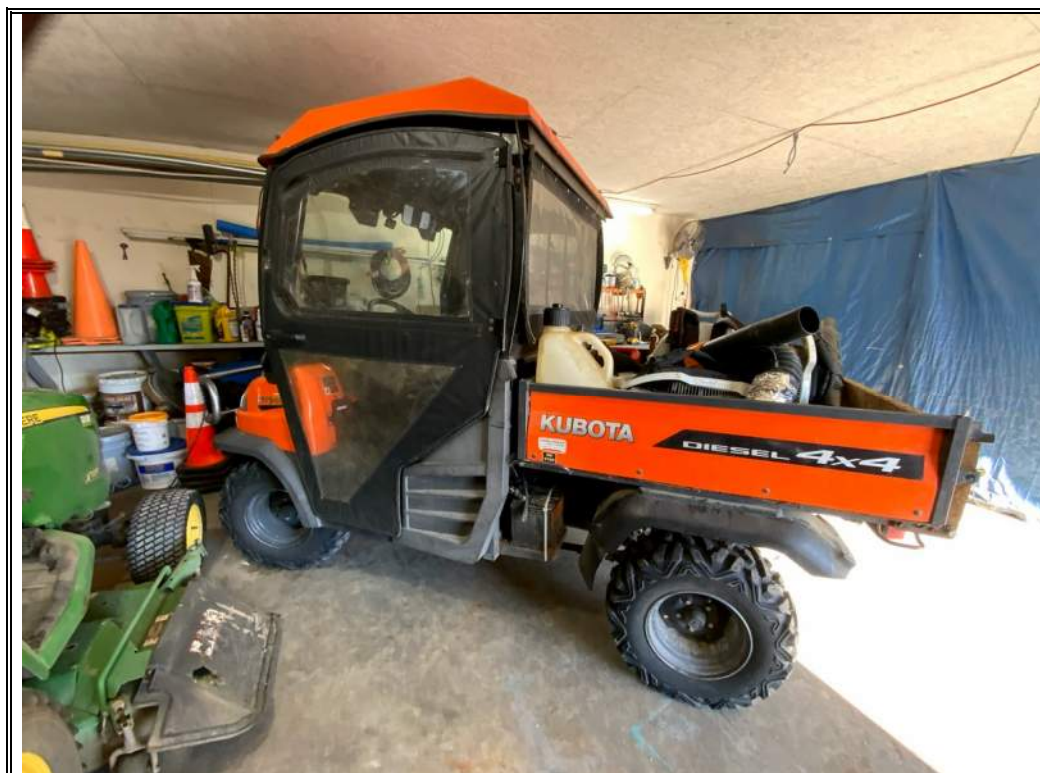
Kubota UTV
